Appendix 3 Site Audit Written Assessment

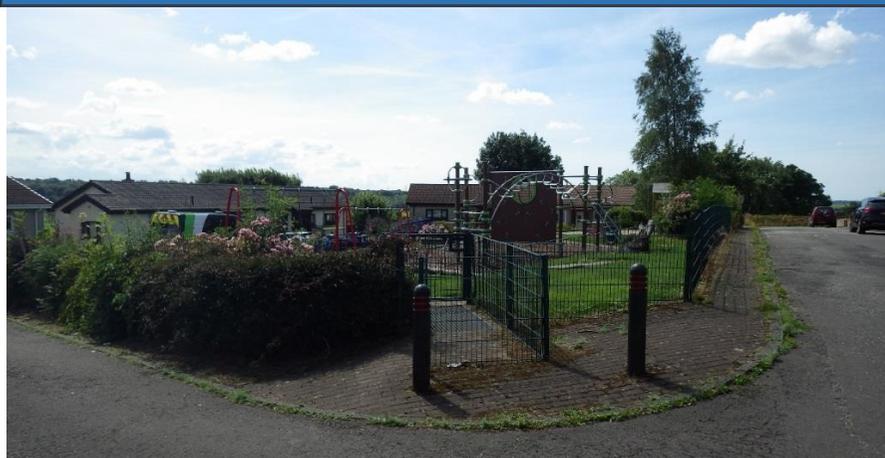
STRO32

The climbing unit is currently being replaced. There is some rot to sections of the wooden edging which require to be repaired. Cut back the shrubs and weed the willow heads and other invasive tree or shrub species.

Some minor works to ensure that the play facility remains fit for purpose. Monitor play facility to ensure it remains fit for purpose.

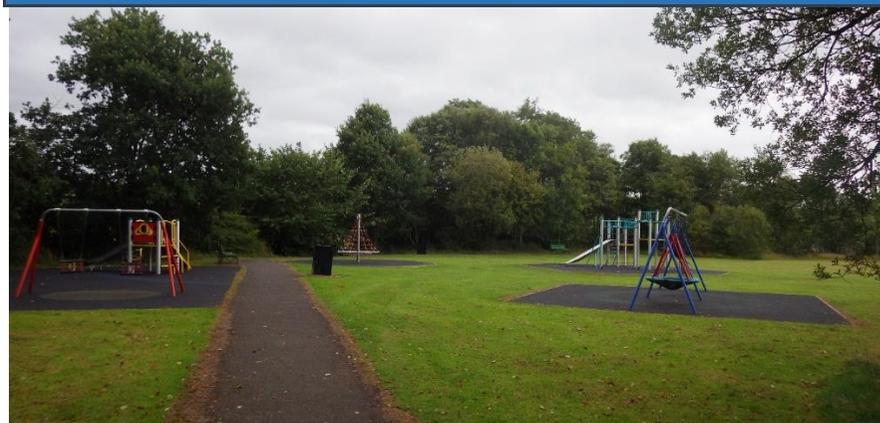
B/M 008

The Open Space Audit identified that there does not appear to be any significant problems on the site apart from a lack of facility and amenity. The play area is currently fit for purpose, however the open space is uninteresting and lacks opportunity for informal play and recreation.

No action is necessary for the play equipment, which is currently fit for purpose. However, the overall play value of the open space should be reviewed alongside the overall upgrading of provision on the site. Opportunities for exploratory play could be extended through the addition of elements like mounds, planting, rocks and wooden stepping features. The use and function of the site could be extended by the provision of circular path routes, attractive amenity tree and shrub planting with all year round interest, seating areas and bulb planting.

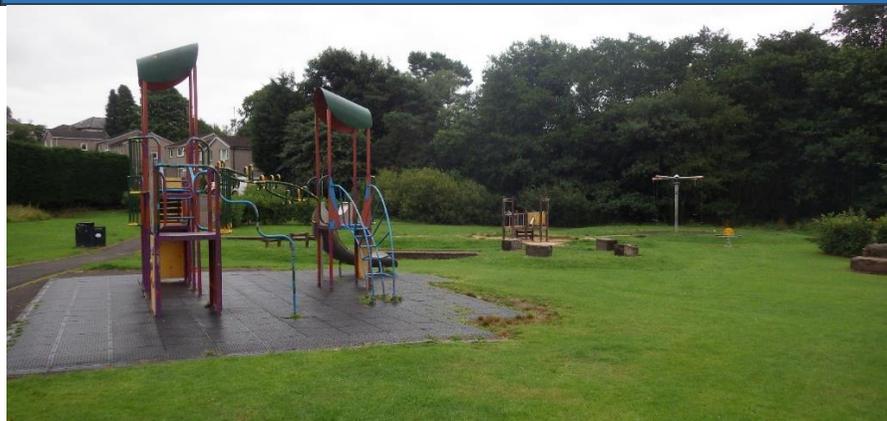
B/M 009

The grass matting is lifting in places and the wooden structures are rotting in a few locations and require treatment. However, the space provides an interesting and adventurous environment for play and exploration. The multi play unit is dated and should be replaced.

Some minor works to ensure that the play facility remains fit for purpose. Replace multi play unit. Repair damaged side to wooden moat.

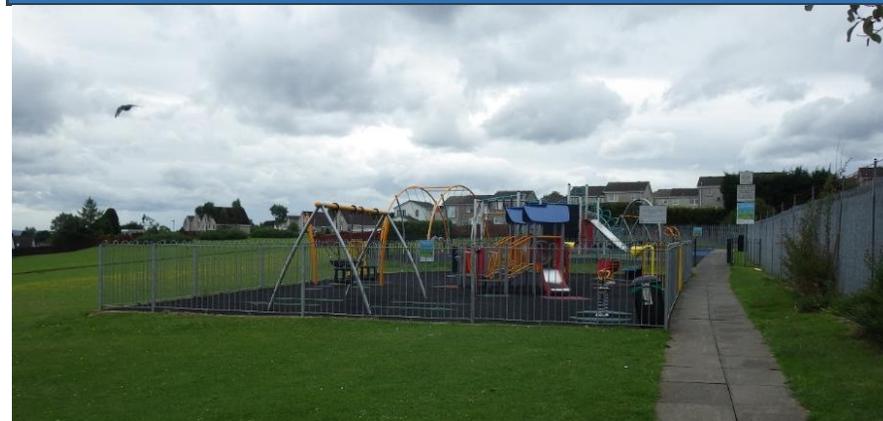
B/M 010

One of the bins is rusting. There is some litter around the play areas. The metal fencing around the rear of the retail buildings is unsightly and detracts from the play area. The play area is recently installed and currently fit for purpose. However, its location to the rear of the shops and the lack of any landscape features / attractive planting / contours in the wider open space has brought the overall score down for environmental factors.

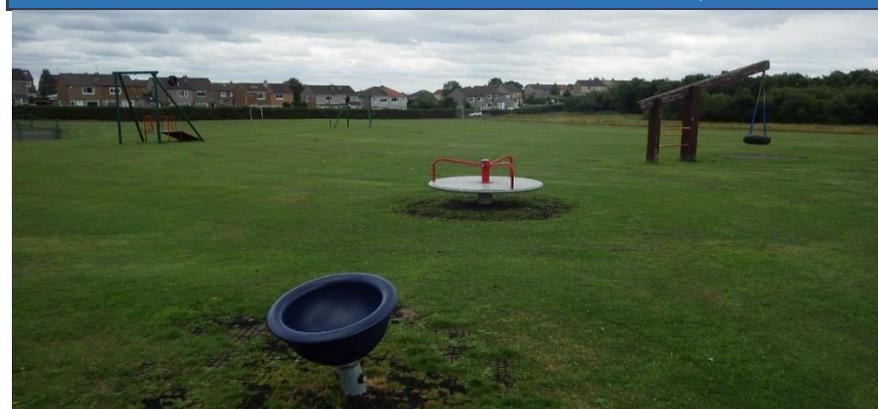
B/M 011

The wooden frame of the tyre swing is needing to be re-stained. The sleepers of the fort are rotting, and some have been removed.

Consolidate the play area and provide a theme to bring the various play / sporting elements together. Repair/ re-stain the wooden structures to ensure they remain fit for purpose. Replace the “Castle” feature and provide more adventure play equipment for older children. Some minor works are required and potentially upgrade in the medium term. Repair or replace the broken zipslide and replace the tyre swing.

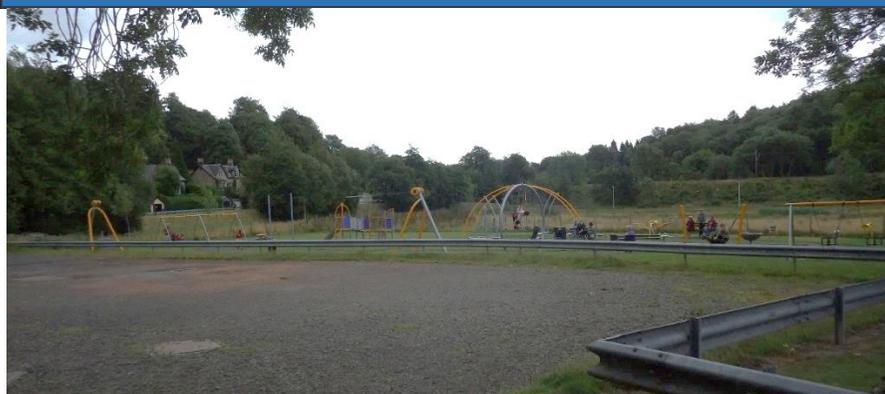
B/M 013

The play area is currently fit for purpose. The post and wire fence is damaged along the western edge of the play area. Improve the entrance and fencing along the western edge of the site.

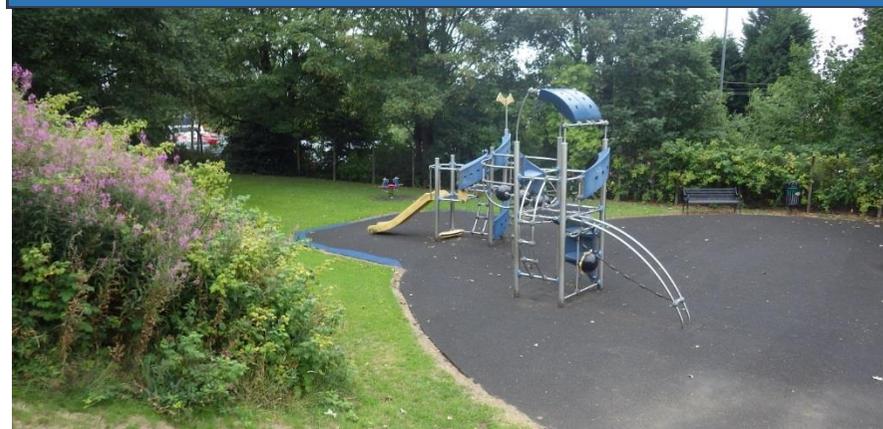
B/M 014

The play area is currently fit for purpose. But there are cracks in the safety surface and lifting edges.

No action necessary. Safety surfacing to be repaired.

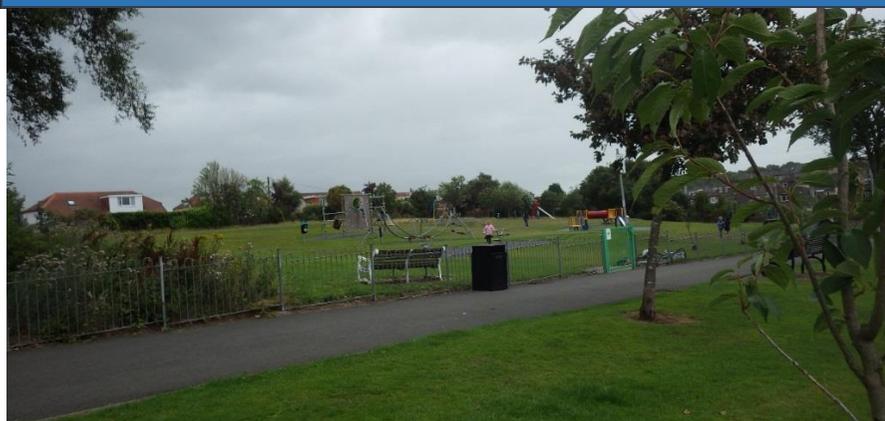
B/M 015

The play area is currently fit for purpose, with the exception of the Proludic Climbing wall which requires to be replaced.

Replace the climbing wall. Upgrade in medium term, in conjunction with the Management Plan (2018-2028) for the park, as the older equipment begins to fail. The feedback from the community consultation identified a

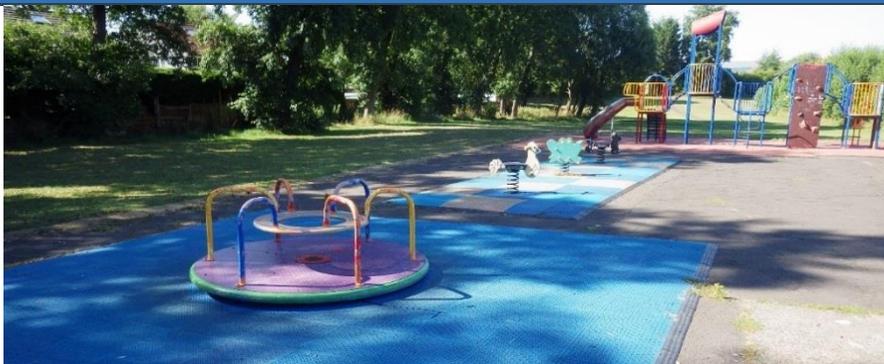
STR017

The play area is currently fit for purpose. However, the roundabout needs to be repainted. There is some graffiti on the climbing frame. Some sections of the safety matting are lifting in places. The eastern play area is looking a bit dated and will need replacing in the medium term as the equipment begins to fail.

Replace the concrete bin. Upgrade in the medium term and consolidate the play areas to provide zones for different age groups. There is new adult fitness equipment proposed for the park.

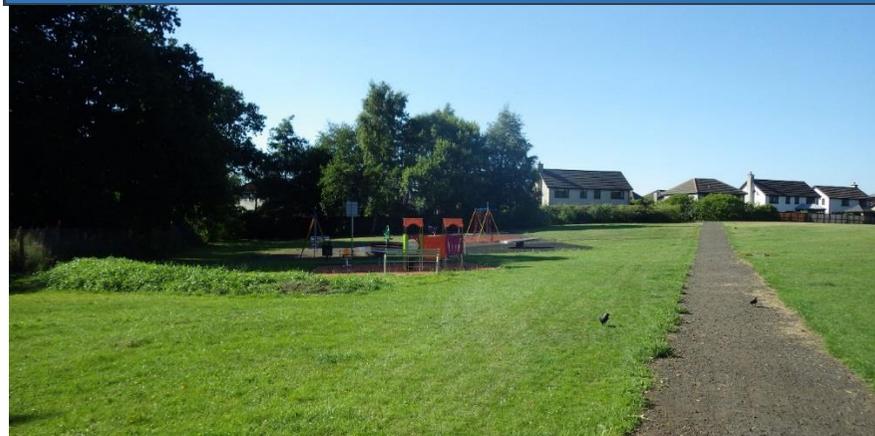
STR018

The play area looks old and tired but is probably well used due to its central location in a residential area. The roundabout surface is cracking. The edges of the safety matting is lifting in places.

Some minor works and potential upgrade in medium term to provide facilities for older children. The older section of the Doune Crescent Play Area requires to be replaced.

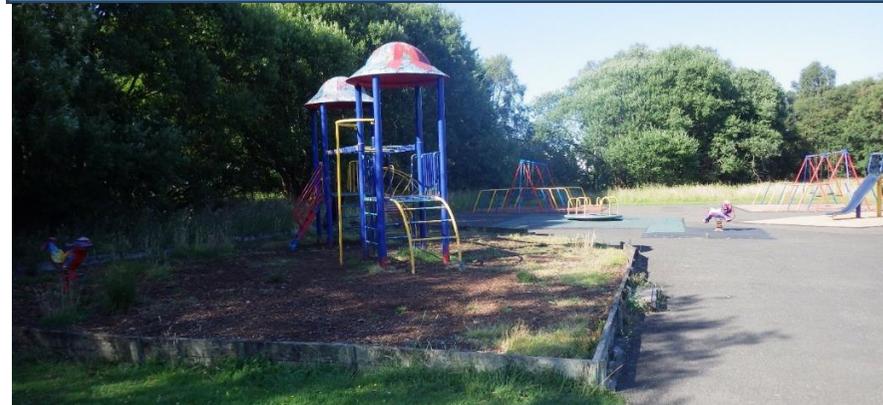
STR020

The play equipment is dated. The play space looks very run down and is probably not well used. The play structures require repainting/replacement. There is evidence of graffiti and broken glass which suggests that it attracts antisocial behaviour. The woodchip surfacing under the climbing frame is weedy and the wooden edges are rotting. The location of the play area in a secluded location and not overlooked by housing will probably exacerbate the problems with anti-social behaviour.

Upgrade in the short term and relocate to a better location, close to the park entrance, residential streets and path networks. A new play area will require to be raised to combat existing drainage issues.

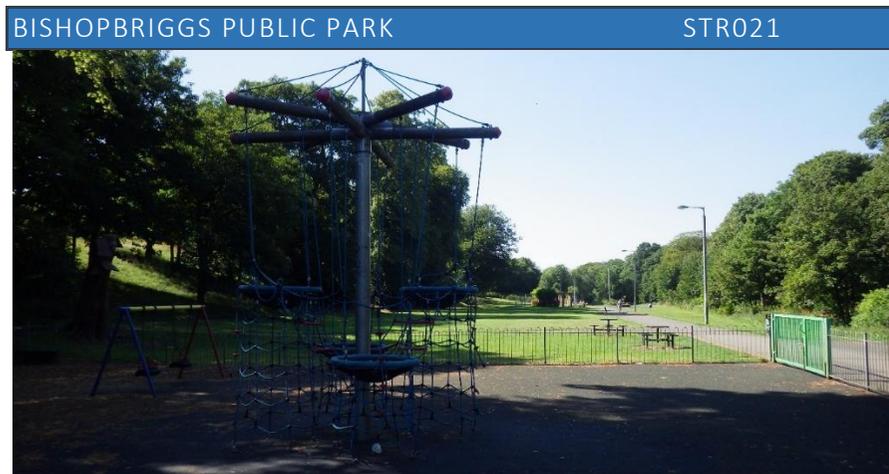
lack of equipment for older children and the play offer could be much improved. The MUGA is in good condition but the metal posts have mould on them and should be scrubbed/ repainted.

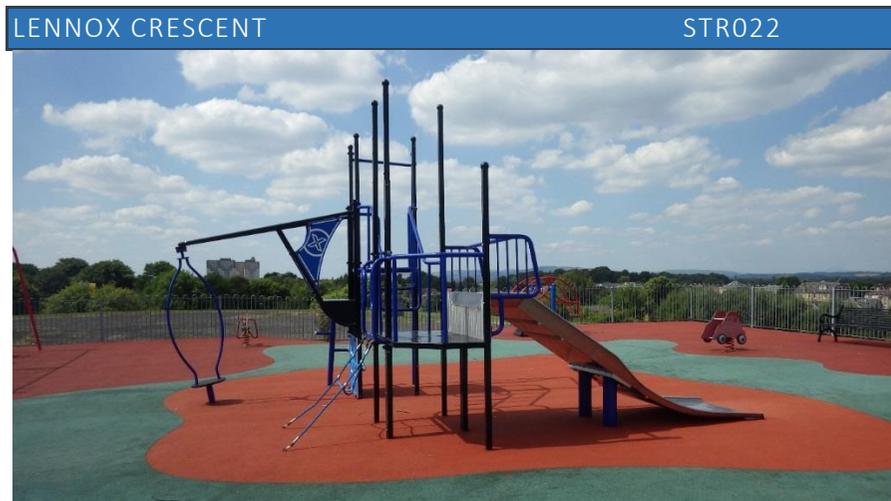
The play area is currently fit for purpose. However, the fences at the entrance to the park are rusting and the overall condition of the park is poor. The open space is uninteresting and lacks opportunity for informal play and recreation.

No action is necessary for the play equipment, which is currently fit for purpose. However, the overall play value of the open space should be reviewed alongside the overall upgrading of the wider park facilities in the medium to long term. Monitor the equipment and replace as necessary. The use and function of the site could be extended by the provision of circular path routes, attractive amenity tree and shrub planting with all year round interest, seating areas and bulb planting.

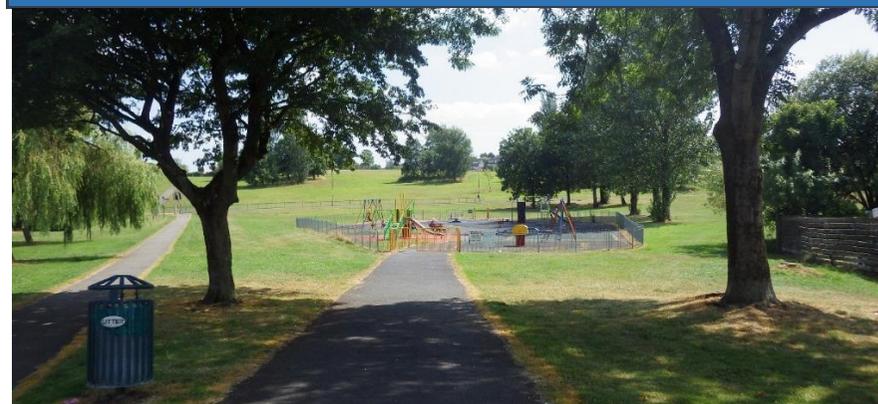
STR026

The litter bin is needing to be repainted. The gates are rusting and do not close on the springs. Most of the play equipment is in good repair, however some pieces of play equipment are showing signs of rust and wear and tear. The benches need repainting / replacing. Some of the grassed areas within the play area are weedy and unmanaged. The edges of the play area are weedy. Some of the edges of the safety surfacing are weedy and lifting in places.

Some minor works to ensure that the play facility remains fit for purpose. Replace / repair the gates. Install equipment for older children / early teens. The area is included in the Masterplan for Woodhill & Etive parks, which seeks to improve the landscape and biodiversity value of both parks and links them through a network of active travel routes. Consider providing areas for personal exercise through natural play and adult fitness. Develop other uses e.g. upgraded play area, allotment and skate park. There is a new skatepark / pump track proposed for the park.

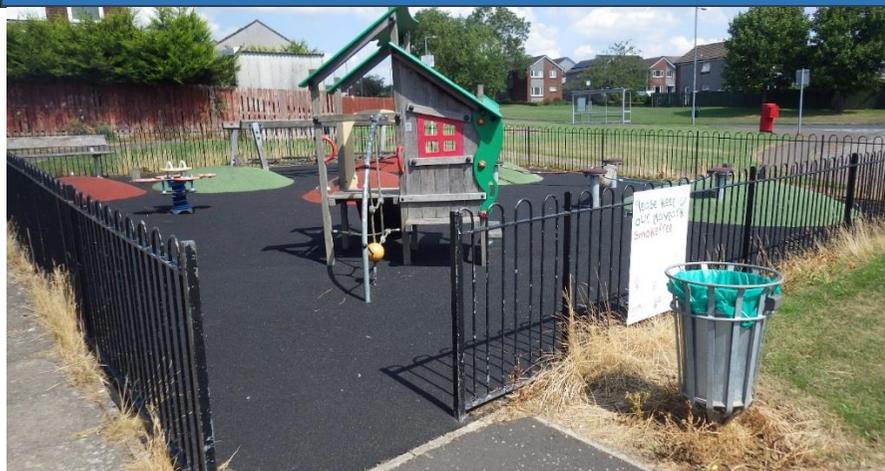
STR031

The play area is in reasonable condition, but the wooden beams need re-staining/ treatment and some of the “hopping” posts are rotting. There is some litter. The boundary fence needs repainting.

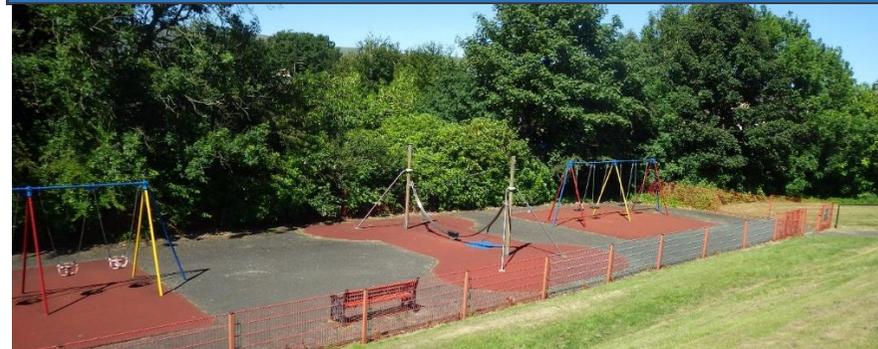
STR050

The metal handrail is rusting and requires repainting. The gate closer is broken. There is some graffiti on the climbing unit backboard, on the site signage and under the slide. This suggests that the play area, in its isolated local may attract anti-social behaviour. The benches need to be repainted.

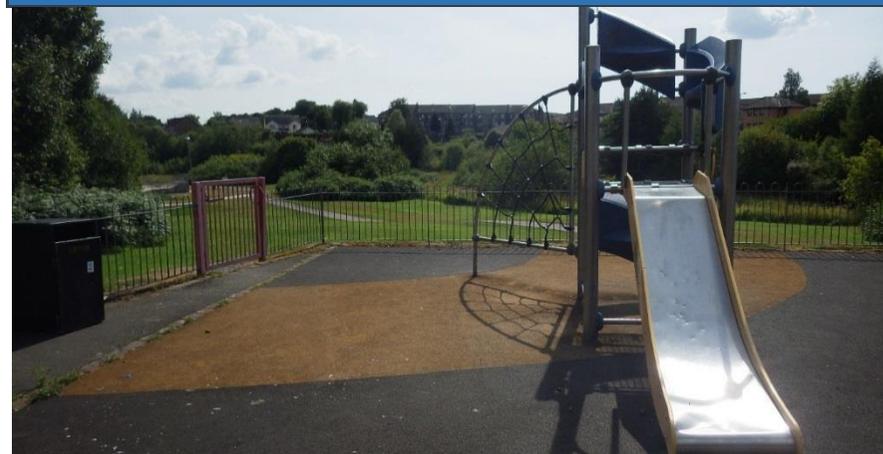
STR052

A frequent visitor to the play area commented on the amount and frequency of broken glass in the play area, which suggests that the area is attracting anti-social behaviour. The secluded location of the play space will exacerbate this situation. One of the gates is missing. The edges of the paved surface is lifting. There is some litter around the play area.

Minor repairs needed to address issues of broken glass. New self-closing gate to be fitted. Upgrade the play facility with addition of play facilities for older children to upgrade to a NEAP.

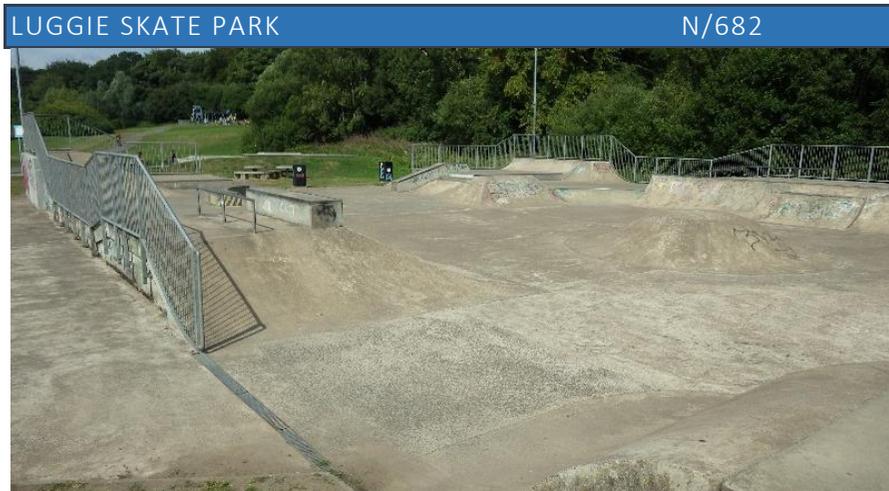
There is some graffiti and some damage to one bin at the skate park.

The skate park is currently fit for purpose. Youth shelter to be considered.

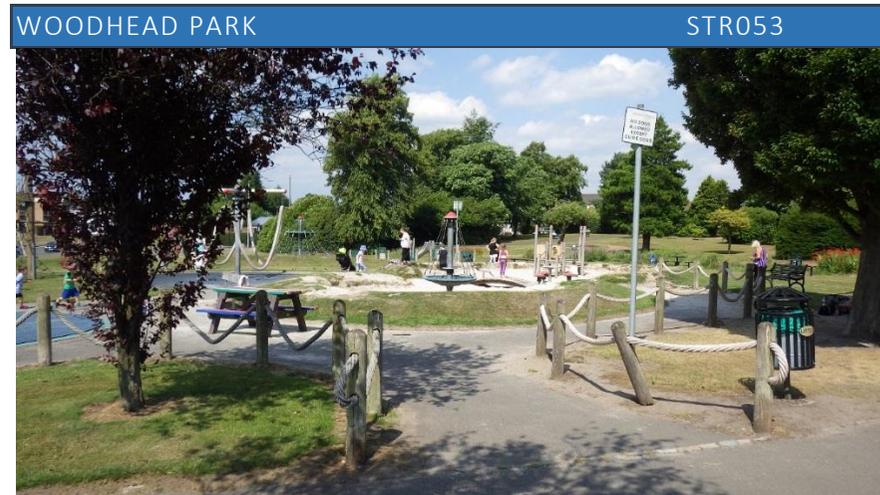
The play area is a well used and popular facility. However, this will have an impact on wear and tear and maintenance demands. In particular, the wooden sleepers around the seating areas are beginning to rot. There is some litter around the picnic areas.

Undertake some minor works to ensure the play area remains fit for purpose. Repair / replace section of rotten wood. The wooden posts that form part of the play equipment require treatment or replacement.

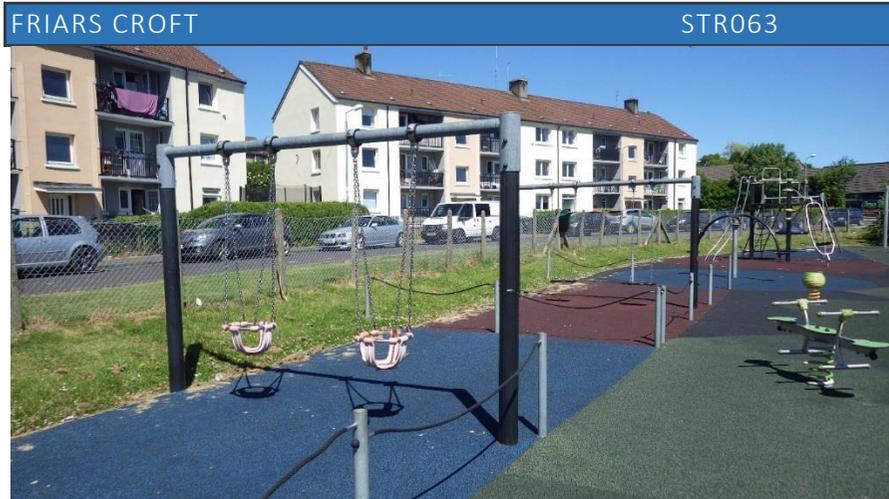
The play area is currently fit for purpose and the play equipment is of high quality and condition. However, the outskirts of the site are a bit untidy and there is some litter. The tops of some of the posts have been removed. There is evidence of people gaining access over the fence at eastern end of the site, suggesting that the site is not secure. The main gates are rusting and in need of repair.

The quality assessment reflects the location in a small site, surrounded by houses, without much landscaping. The overall landscape quality of the site should be improved with amenity tree and shrub planting. Replace the boundary fence.

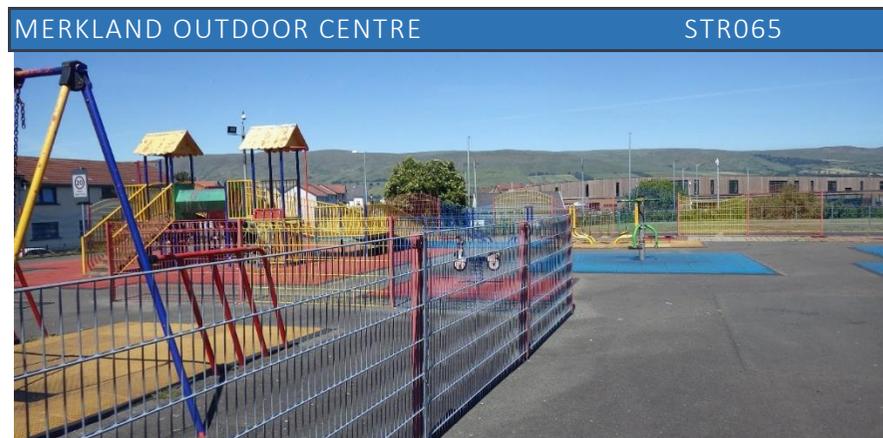
paint scraped off. Some wooden slats on the play equipment require restraining. Boundary metal fencing requires repainting but is in overall good condition. Some of the signage is illegible.

Ongoing minor repairs to the play equipment and safety matting to ensure that the play area is fit for purpose. Upgrade the play facility in the medium term. Addition of play facilities for older children / young adults to upgrade the facility to a NEAP.

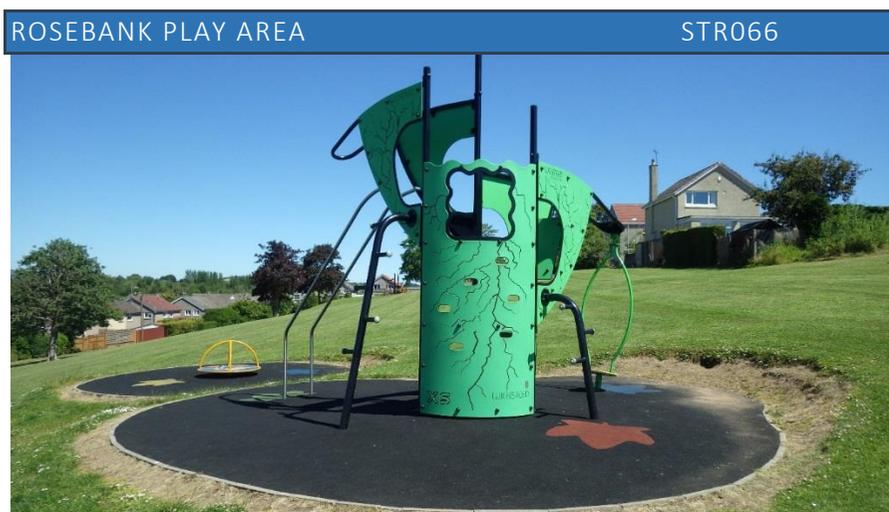
The play area has been recently installed and is fit for purpose. The edge of the bitmac around the fitness equipment is pitted and cracked and weedy at the edges. There is some broken glass and litter around the fitness equipment.
