Bishopbriggs War Memorial Hall

Existing Interior Bishopbriggs War Memorial Hall

Proposed Plan Bishopbriggs War Memorial Hall

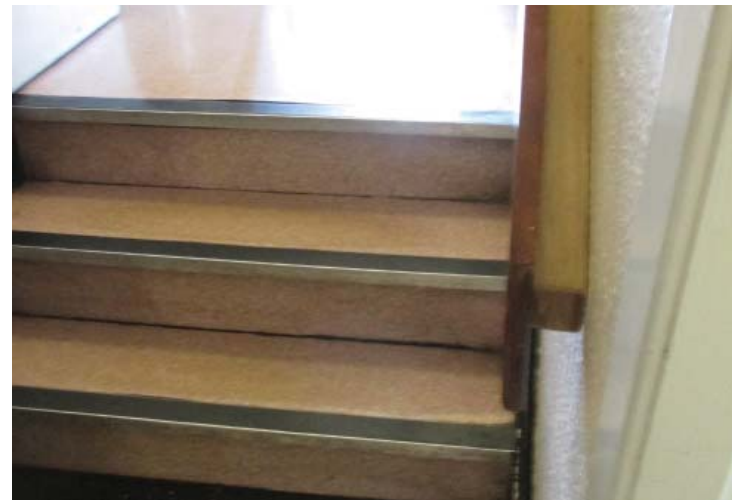
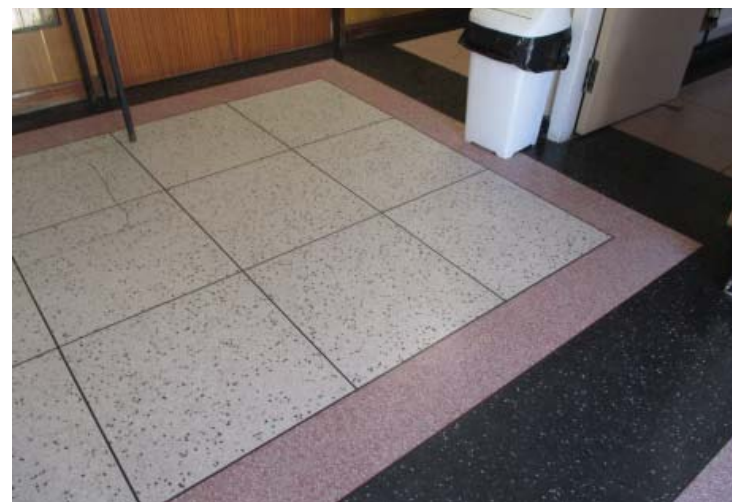
The ancillary spaces are dated; modernisation is required throughout. The current storage space underneath the stage is hazardous to use. The steps towards the lesser hall make this more difficult to access. The existing terrazzo flooring is of a high quality and is hoped to be retained.
