## Evidence Report B: Network Audit

Forth and Clyde Canal near Kirkintilloch

Throughout 2021 and early 2022, Council officers undertook an audit of the existing network of off-road, active travel routes in East Dunbartonshire through site visits. This work informed the evidence reports for the Active Travel Strategy that were approved by PNCA Committee in January 2023.<sup>1</sup> In 2026, revisions have been made to ensure that the audit reflects more recent changes to the network through a combination of verification of the Network Audit with council officers and some limited site visits.

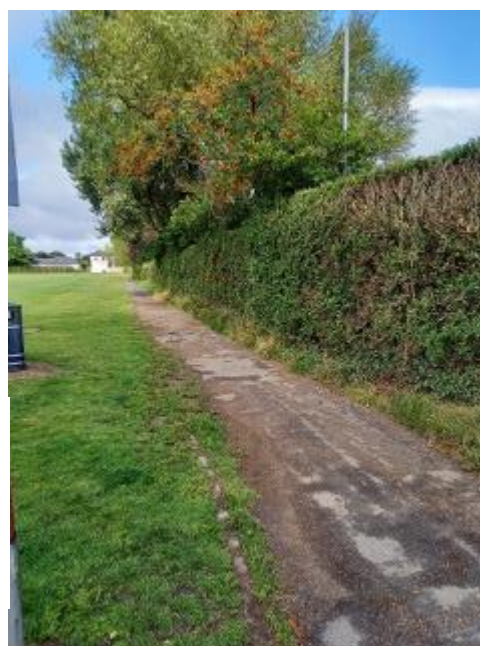
The route information function in Collector App allows the auditor to judge who can comfortably use the path and the path's condition. The image (right) is a path in Bearsden that was classified as in fair condition and usable by foot, bike and wheelchair. It is therefore a useful baseline to set as an average path in Bearsden, it functions as a path but clearly could be improved and therefore is judged to be in fair condition.

A path in fair condition in Bearsden – it could feasibly be used by walkers, cyclists and wheelers but clearly the surface could be improved and the route could be better maintained to ensure vegetation growth does not present an obstacle to users.

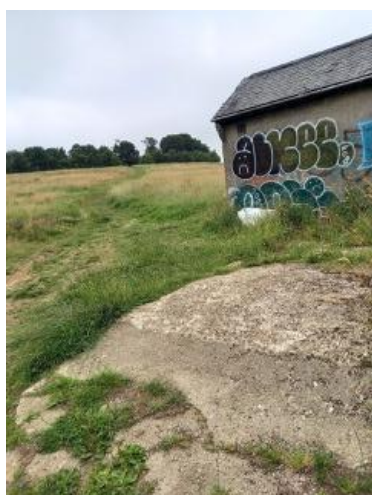
Pictured (left) is a grass path in fair condition for walking. It is on the outskirts of the town and is not an important route connecting people to everyday needs. The path pictured right, on the other hand, is a good, hard surface path for walking, cycling and wheeling. Paths like these, connecting residential areas and important services (in this case, a leisure centre and a library), are important to maintain to ensure everyone can access and use the

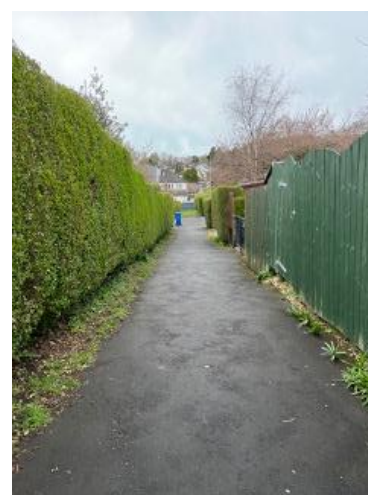
path. One issue with these types of path is safety. Although lit, the path lacks passive surveillance and, as a result, will be underused at night and during winter months. It is important to consider the quality and accessibility of on-road alternatives for when people naturally avoid off-road routes.

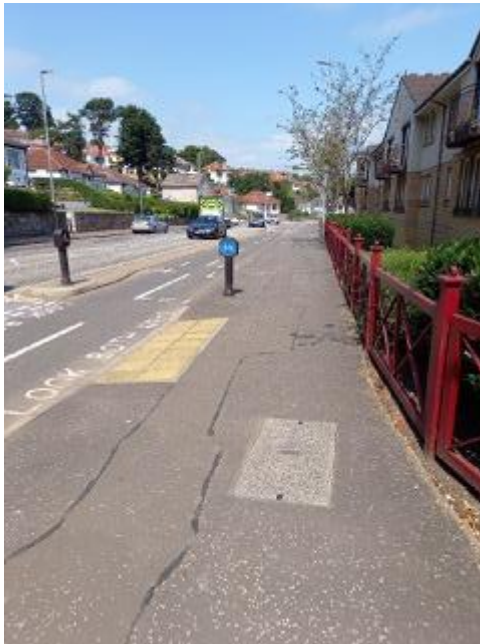
Bearsden has a high number of paths that are accessible for walkers, cyclists and wheelchair users. Pictured (left) is Bears Way, approximately 150 metres from Hillfoot rail station. It is an important, high-quality segregated cycleway. As on-road infrastructure, it enhances the pedestrian experience as traffic is further from the footway. There are some barriers on the route (discussed below) and the route fails to connect Hillfoot station and Milngavie town centre. This means that cyclists must choose to either cycle on-road amongst traffic or ride on the pavement (cycling on the pavement contravenes the Highway Code). Some cyclists lacking confidence riding in traffic choose to ride on the pavement which, in turn, impedes pedestrians and wheelchair users. This conflict was experienced during the network audit and the auditor considered it noteworthy. There is extensive evidence that segregated cycle infrastructure in Scotland increases active

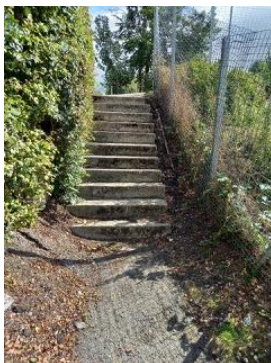
In some instances, barriers exclude wheelchair users from routes and make journeys more difficult for cyclists. Two examples are the Jubilee Path near Hillfoot (pictured left) and the bridge over the canal near Westerton Station (pictured right). In both cases, ramps could be retrofitted to ensure those with impaired mobility can safely use these important routes.

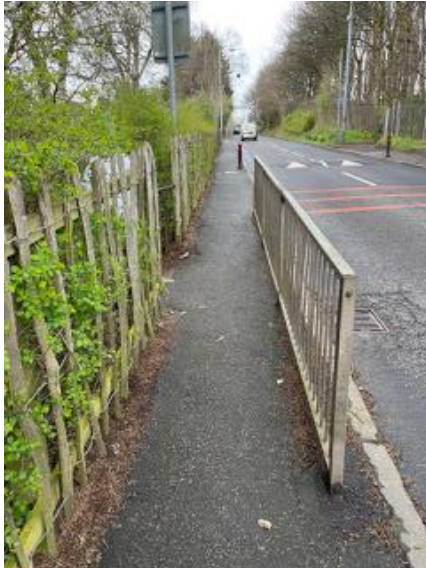
When combined with narrow footways, barriers like this between Westerton and central Bearsden represent significant obstacles to active travel for those with limited mobility or those carrying loads, pushing prams etc.

Finally, on a narrow footway, this barrier (pictured top left next page) presents a significant obstacle for people wheeling or pushing prams or trolleys. If a comprehensive network for active travel is to serve the places people want to go in East Dunbartonshire, obstacles like this must be removed and footways must be made accessible for all.

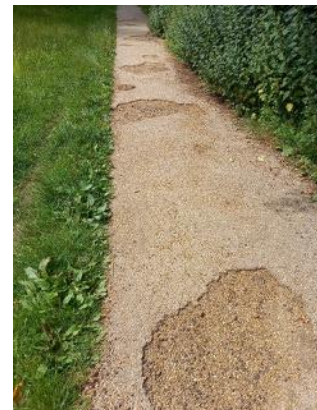
Pictured (above right) is an example of moderate surface damage. It is moderate as it does not completely impede active travel but if it continues without maintenance it will exclude users from that path. Pictured (right) is an example of moderate tree root damage on Jubilee Path, a strategically important route linking Bearsden town centre, a nursery and Hillfoot shops, station and residential areas. It is noted that this path has since been upgraded (2025).

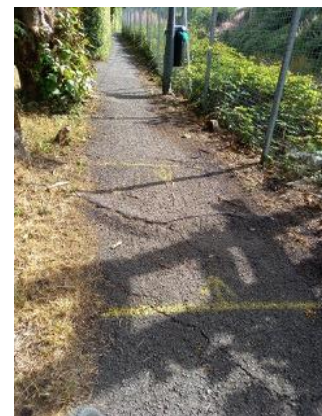
There were at least 45 recorded signs on the off-road active travel network in Bearsden. The most common were blue signs that direct people to places of interest and provide estimated journey times for walking and cycling. In two cases these signs were damaged (one obscured by leaves and the other bent out of shape, as pictured right).

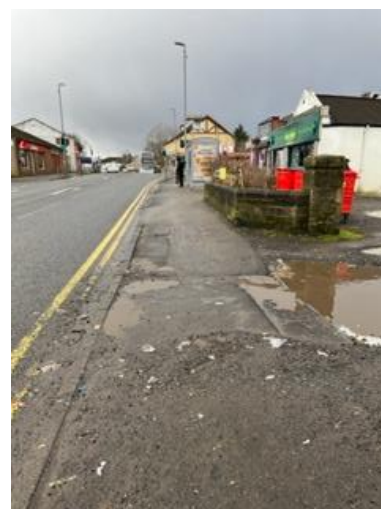
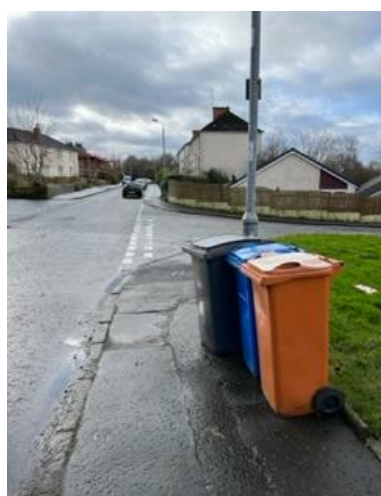
Multiple Deprivation. Auchinairn is located next to Bishopbriggs but lacks direct train services to Glasgow. Whilst in Auchinairn, an auditor noted the particularly poor condition of pavements connecting residential areas with key services such as shops, the community hub and a pharmacy. Pictured (right) is an example of a poor pavement surface near local amenities in Auchinairn. Pictured (below left) is another example of hostile pedestrian environments in Auchinairn. Wheelchair users or people pushing prams will be forced onto the road and face a lack of dropped kerbs and long crossings. To ensure equal access to local services and amenities, pedestrian infrastructure should be assessed and upgraded in East Dunbartonshire.

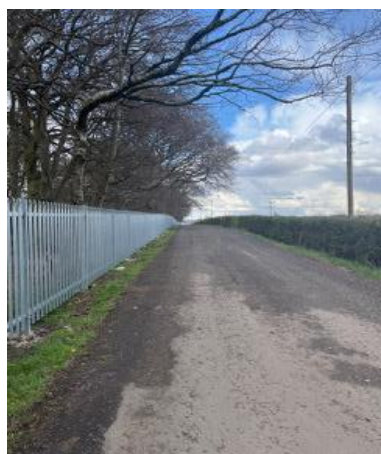
The path pictured (left) is a gravel path for walking, cycling and wheeling, graded fair. This path is generally fit for purpose. However, it is signed as the main cycling route from Bishopbriggs to Glasgow, a purpose for which it is not fit and it is neither the most direct nor the quickest route. The poor surface in comparison to main roads and the indirect nature of the route results in cyclists either using busy, main roads, adding time to their journey or choosing a less sustainable form of transport.

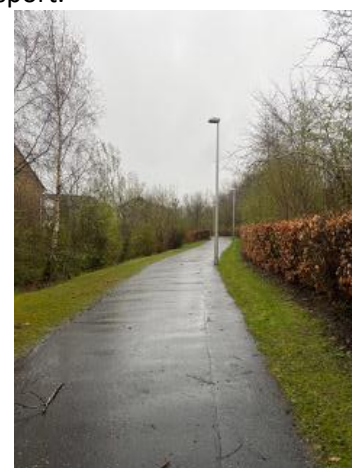
Pictured (right) is an example of high-quality off-road active travel infrastructure in Bishopbriggs. The recently developed area to the east of Auchinairn has a somewhat extensive off-road network. There is an opportunity to extend this towards Auchinairn and Bishopbriggs to reduce car dependency and improve transport links to neighbouring, deprived, areas.

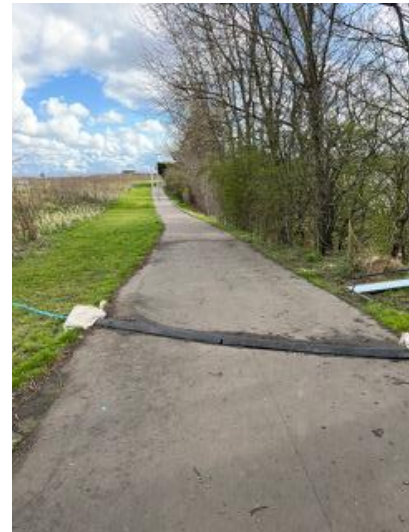
Pictured (top right) is a barrier that did not fit in any of the prescribed categories. This barrier was due to temporary works on Wester Way and it impeded cycling and wheeling on the otherwise high-quality route.

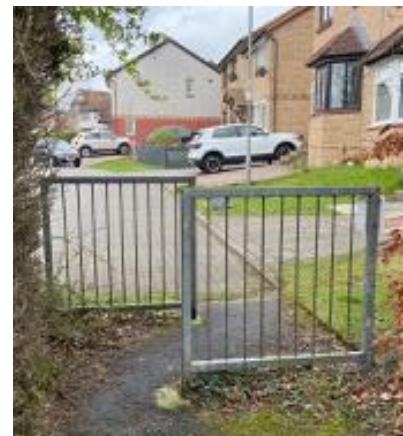
Pictured (right) is one of Bishopbriggs' gates which act as a barrier to active travel. A person with unrestricted mobility may not notice an issue with this infrastructure but those who use wheelchairs or push prams will find these barriers restrictive to their ability to move around. If East Dunbartonshire is to be a welcoming, enjoyable place to travel around actively for all, these barriers need to be addressed.

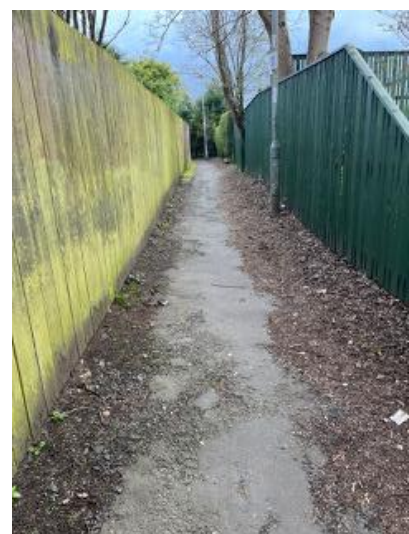
One minor and two moderate instances of surface damage were recorded (moderate damage pictured right). Two instances of minor damage due to vegetation were recorded. One instance of minor pothole and minor tree root damage was recorded. The surface damage pictured (right) is combined with vegetation which could be better maintained by the Council.

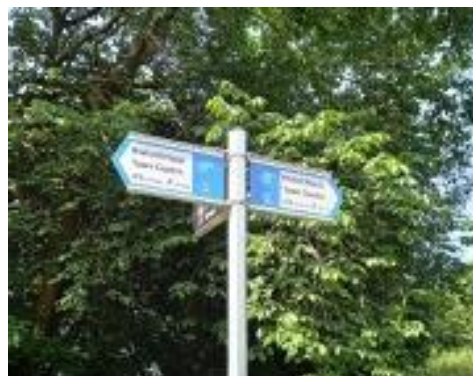
Bishopbriggs, and particularly its urban path network, lacks the comprehensive signage of other parts of East Dunbartonshire. Signage is largely limited to Canal paths and paths through Bishopbriggs Park. Aside from one damaged sign that was twisted to point in the wrong direction, there were nine existing signs in reasonable condition. A typical sign from the Canal path and park is pictured (right). These signs are understandable and similar to typical blue active travel signs seen throughout the region.

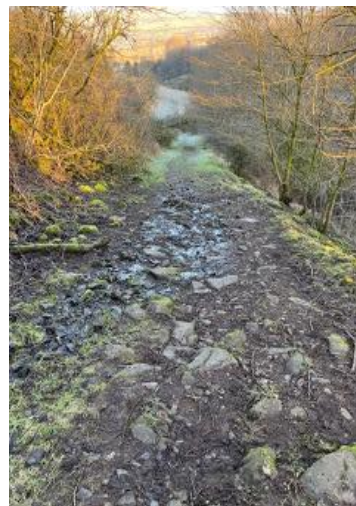
General comments informed of various features and issues: access to Waterside Bing is confusing as there is no access through the depot; there is lighting on the floor of a few paths (notably north of the Canal in Kirkintilloch to St. Ninian's High and in Twechar – the auditor asked whether this lighting is fit for purpose i.e. bright enough to provide users with a feeling of safety; steep and slippery surfaces (pictured right) were noted in Twechar as well as a steep section up towards Bar Hill although a path bypassing this section was available - this area was also noted to require better signage as walkers could become disorientated; a path west of Kirkintilloch was noted to have poor access via a fast road and narrow footway.

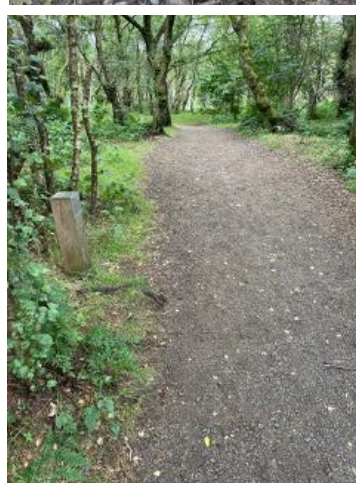
Kirkintilloch has a mix of urban, suburban and rural paths so there are significant variations in surface, quality and intended users of paths. Pictured (right) is a section of path at Lenzie Moss, this is a good quality gravel surface which could be used comfortably by walkers and cyclists. The path is inaccessible to wheelchair users due to the sections of boardwalk which cross boggy areas.

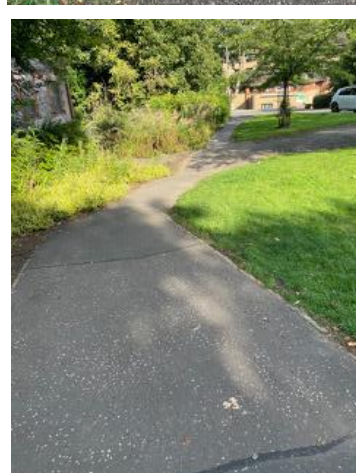
The path pictured (right) is a short, hard-surfaced off-road route in Lenzie, graded good. That said, the path has a notable slope and may cause issues for wheelchair users. Paths that form an accessible active travel network should consider the needs of all users.

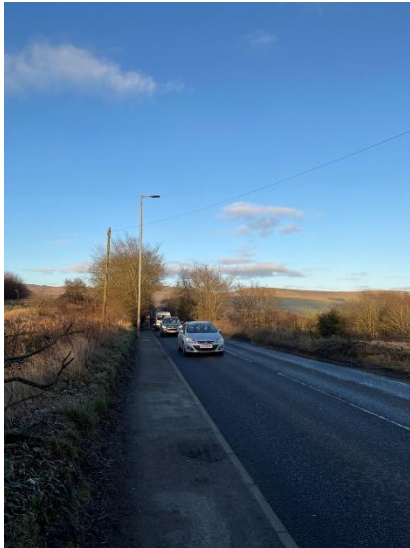
Like other parts of rural East Dunbartonshire, there are numerous gates on routes intended for walking (at least 19 recorded). The majority of these gates are in very good condition and are fit for purpose. More concerning as a barrier to active travel are uncontrolled road crossings (13 recorded) like that on the John Muir Way east of Twechar (pictured below left) and in Twechar itself, a town that commercial traffic uses as a cut-through. Such crossings - such as at the gap in the active travel route where the main street and B8023 intersect - are hazardous to walkers and present a significant barrier to active travel. Other barriers included

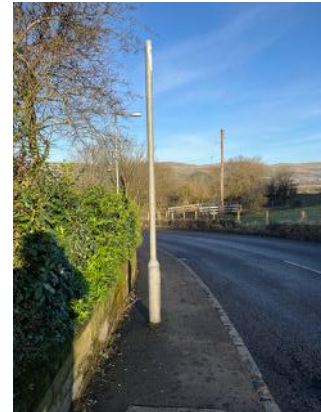
Like the path gradient observed in Lenzie, a barrier to active travel that may go unnoticed was recorded in Twechar. Located on the main street the placement of this pole (pictured right) makes it difficult for wheelchairs and prams to pass and people with mobility issues may be forced closer to the road than they would like.

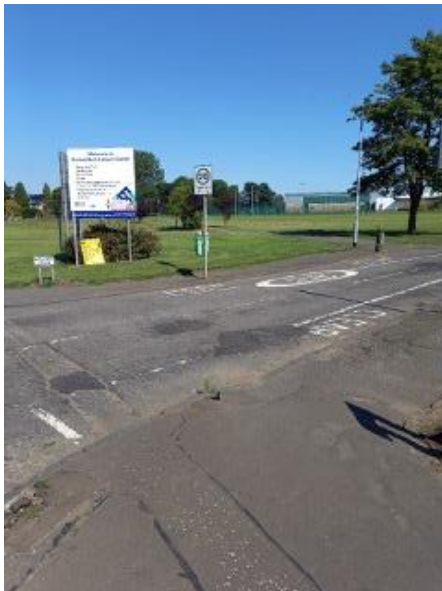
Pictured (left) is an example of a poorly maintained crossing with issues relating to surface, kerb and lack of amenity to help pedestrians cross safely. A combination of these factors both in this instance and at many other crossings and paths in East Dunbartonshire combine to contribute to people making unsustainable transport choices.

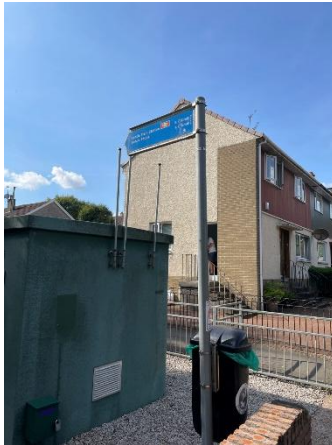
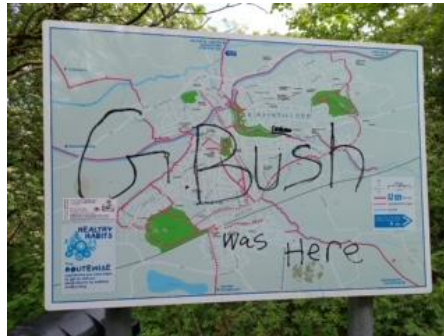
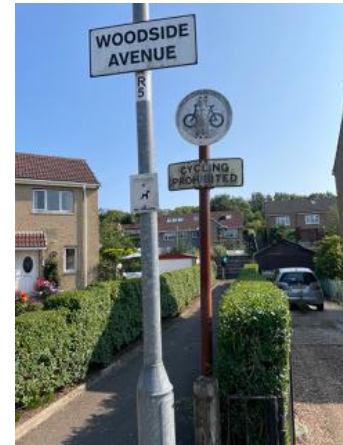
A problem in Kirkintilloch is damage to signs (7 instances recorded). Stickers, graffiti (pictured below middle) and burns mean some signs are not fit for purpose. Auditors judged there to be 7 instances where signs were missing or would be helpful for people using the off-road network.

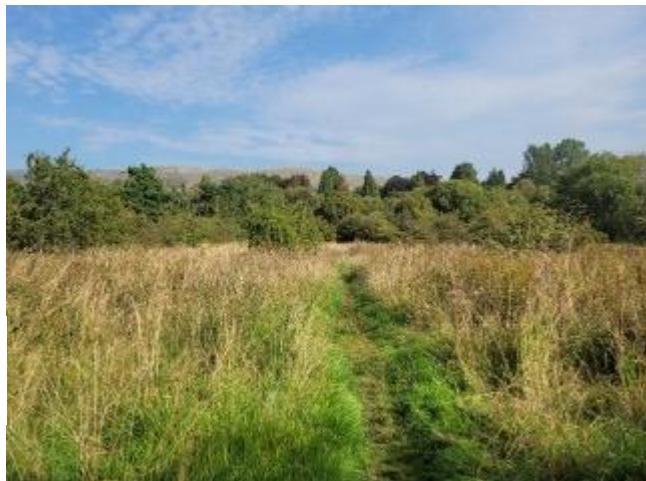
A path typical of rural parts of East Dunbartonshire and the Lennoxtown area in particular. This path is graded fair with a mud surface suitable for walkers.

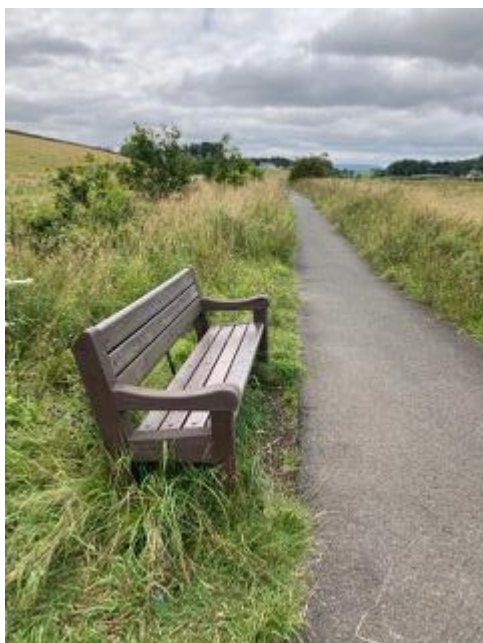
SRP, east of Lennoxtown. Part of the national cycling network, this route was graded good.

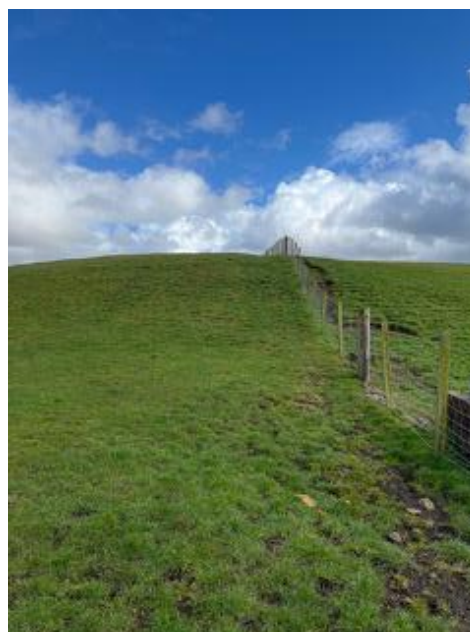
This route (pictured top right), from north Lennoxtown towards Milton of Campsie, is typical of a fair or good route for walkers. Clearly cycling and wheeling is not feasible for this route and, in rural areas, it is not necessarily an achievable nor desirable aim to make all paths entirely accessible.

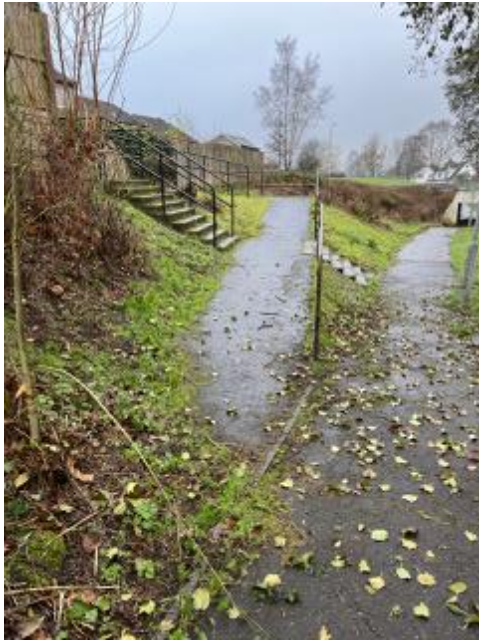
There are numerous barriers on the off-road active travel network in Lennoxtown. Some paths that could be suitable for walking, cycling and wheeling are made unsuitable due to barriers. For example a path in Lennoxtown with a ramp designed to give access to those unable to use the adjacent steps but the ramp is too steep and slippery to provide genuine, easy access (pictured below).

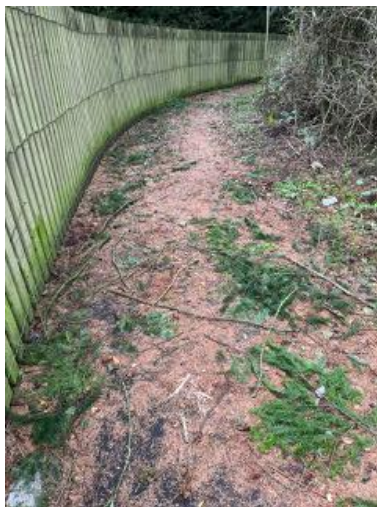
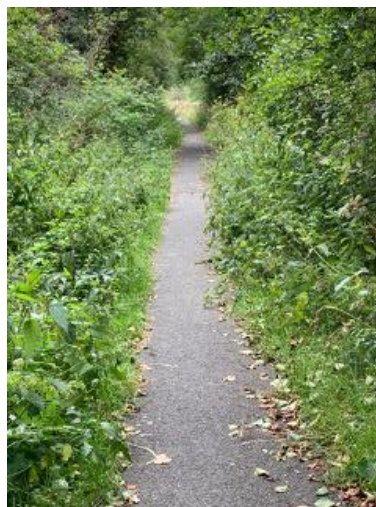
Rural maintenance issues on paths intended for walking (of which there are many in Lennoxtown) are typically a less immediate concern than those on paths intended for walking, cycling and wheeling and urban/suburban paths that link residences with important services and amenities. Pictured below (left) is an example of an urban path in Lennoxtown

that has serious maintenance issues which render the path difficult to use.

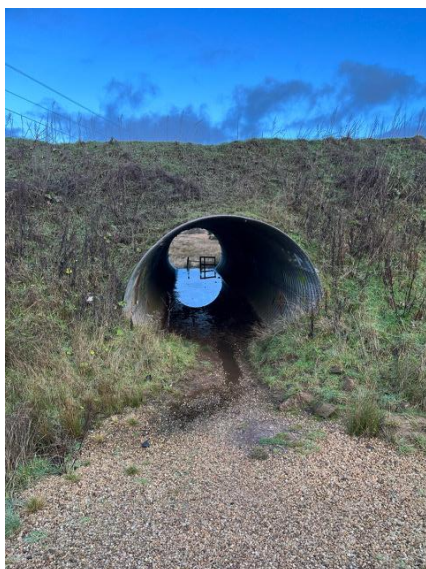
General comments highlight issues, infrastructure and characteristics of paths that are not accounted for in the other categories. General comments recorded in Milngavie included a tunnel (pictured below), educational signage and a slippery, rocky section of path on the Clyde Coastal Path which would make use of the path difficult for those with impaired mobility. Closer to Milngavie town, there were other issues with the Clyde Coastal Path where signage was unclear and the path followed the route of a very narrow country road which puts active travellers in close proximity to traffic.

Tunnel on the Clyde Coastal Path outside Milngavie

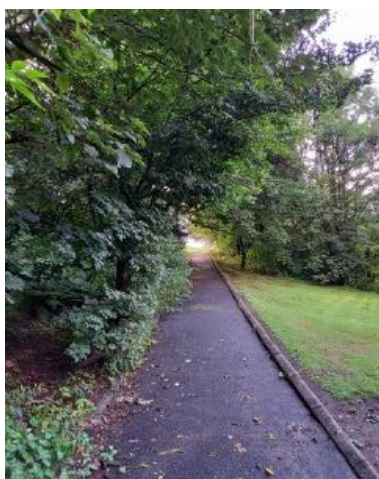
Pictured (left) is a hard, off-road path for walking, cycling and wheeling graded good in Milngavie. Pictured in midsummer, vegetation provides a minor barrier to active travel and requires maintenance.

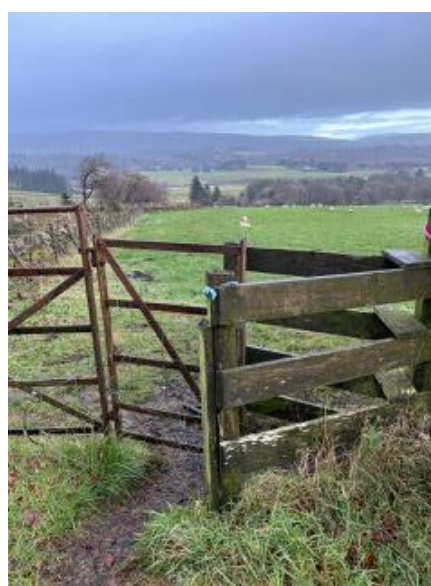
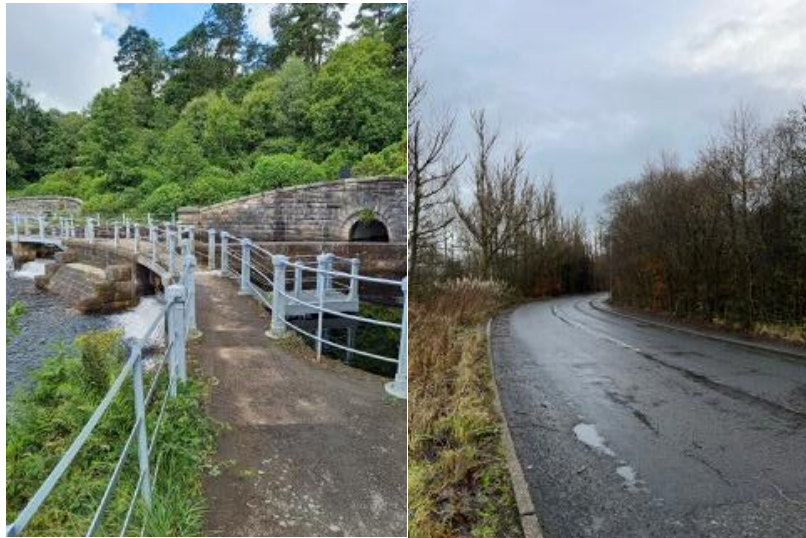
At the popular Mugdock reservoir, narrow bridges present barriers to wheelchair users and people with prams (pictured below left) on some sections, albeit alternative routes are available.

Uncontrolled road crossings are, like elsewhere in East Dunbartonshire, a risk for those using the off-road active travel network. This one (pictured below right) east of Milngavie followed the route of a narrow country road.

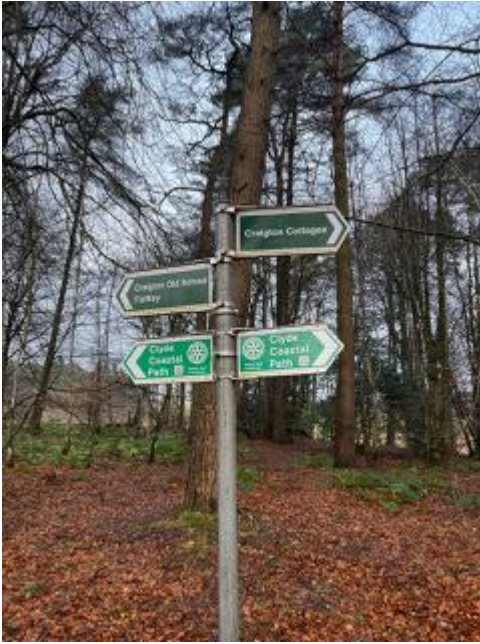
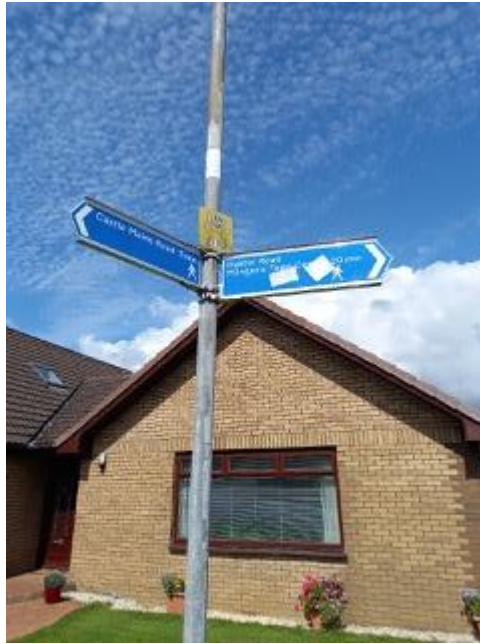
The network audit recorded several places where signage was damaged (mostly from graffiti or stickers as pictured below), falling or being obscured by vegetation.

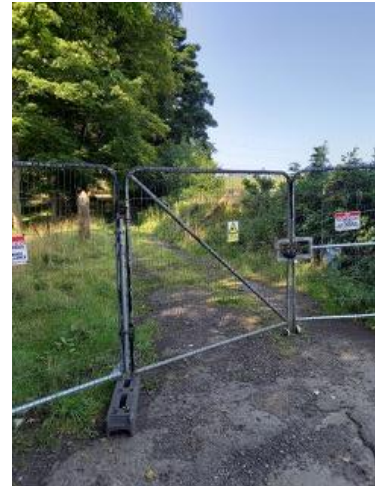
As the picture (right) shows, there were several routes labelled on the map in Torrance that were inaccessible due to either a lack of access or poor condition.

There was a difference in the condition of urban and rural paths in Torrance. Within Torrance, paths were mostly graded good with three exceptions, whilst outside Torrance only one path was graded good.

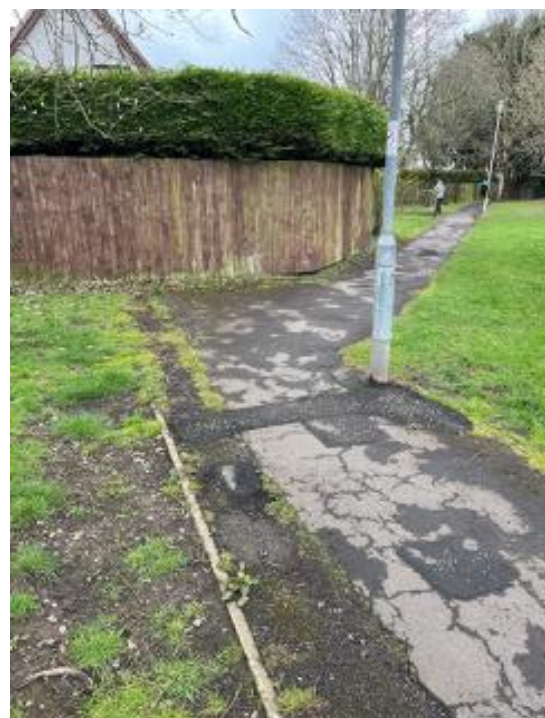
The route information data in Torrance suggests significant maintenance issues in the area. That said, most of the paths are rural and not well-used. It would be a better use of resources to focus on well-used urban paths with maintenance issues that exclude some people from using the active travel network, such as this surface damage pictured in Torrance (right).

In Torrance, there was surface damage (1 serious, 6 moderate and 3 minor). Notably, there were recent

repairs to surfaces on paths that had made problems worse (pictured right).

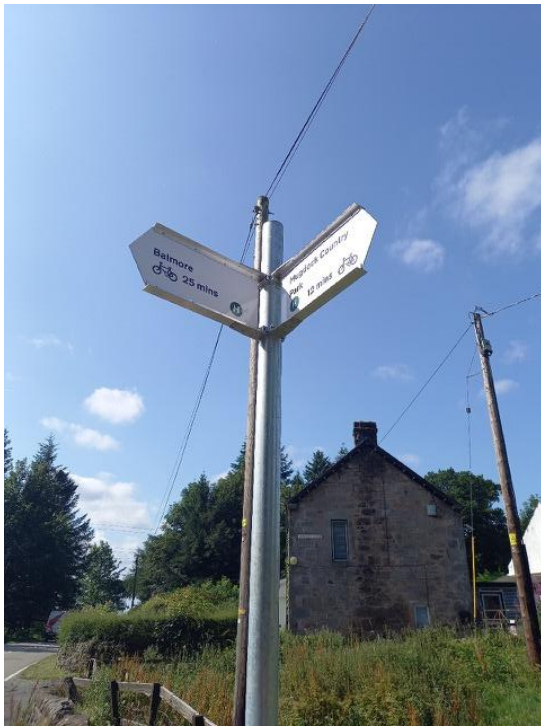
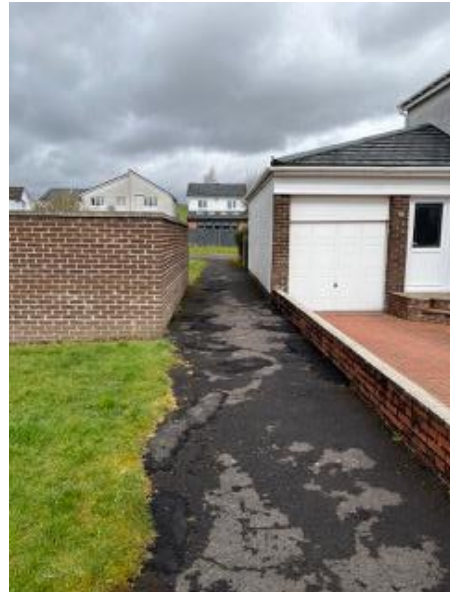
Signage in Torrance is typical of the area as a whole. Notably, there were five recorded healthy habits signs with cycling journey times to nearby points of interest and towns (pictured below).
