# East Dunbartonshire Council

## Open Space Audit

2025

| Document Type | Audit Report |

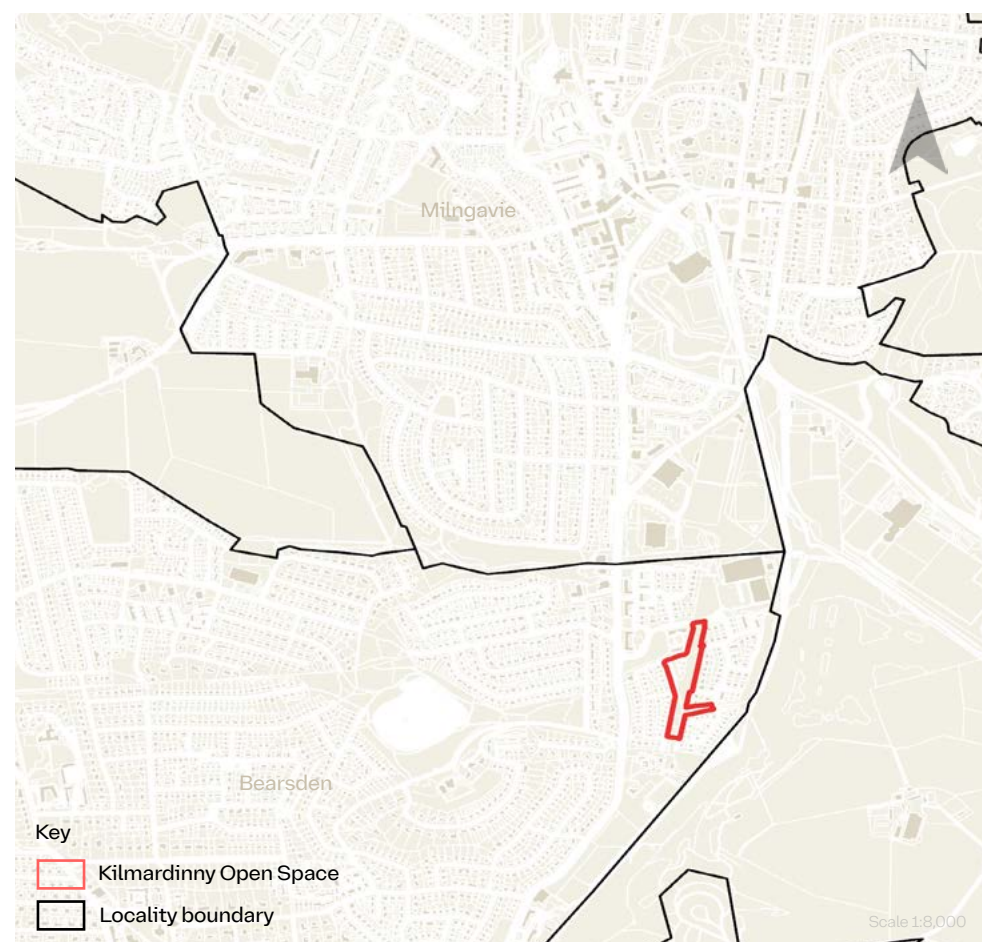
Figure 5. Boundary of Kilmardinny (North) Open Space

- Kilmardinny (North) – Amenity Greenspace (Figure 5)
- Broomhill Hospital Site 1 – Natural/Semi-Natural Greenspace (Figure 6)
- Broomhill Hospital Site 2 - Natural/Semi-Natural Greenspace (Figure 6)

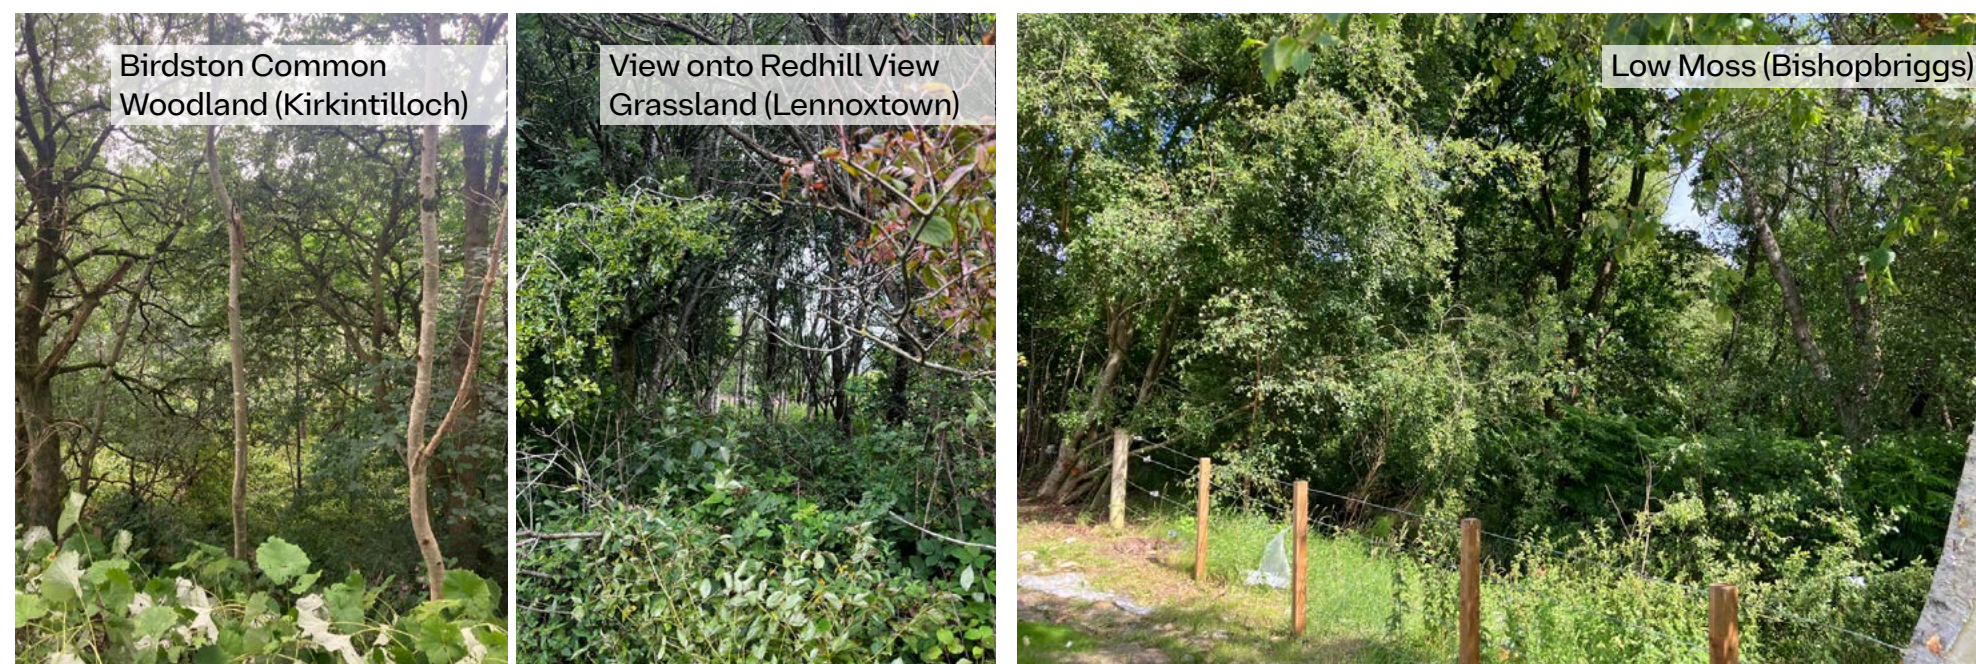
Figure 7. Site Photos of inaccessible sites

During site visits, 15 locations were found to be either inaccessible or unsuitable for public use and therefore have been excluded (Figure 7). These include:

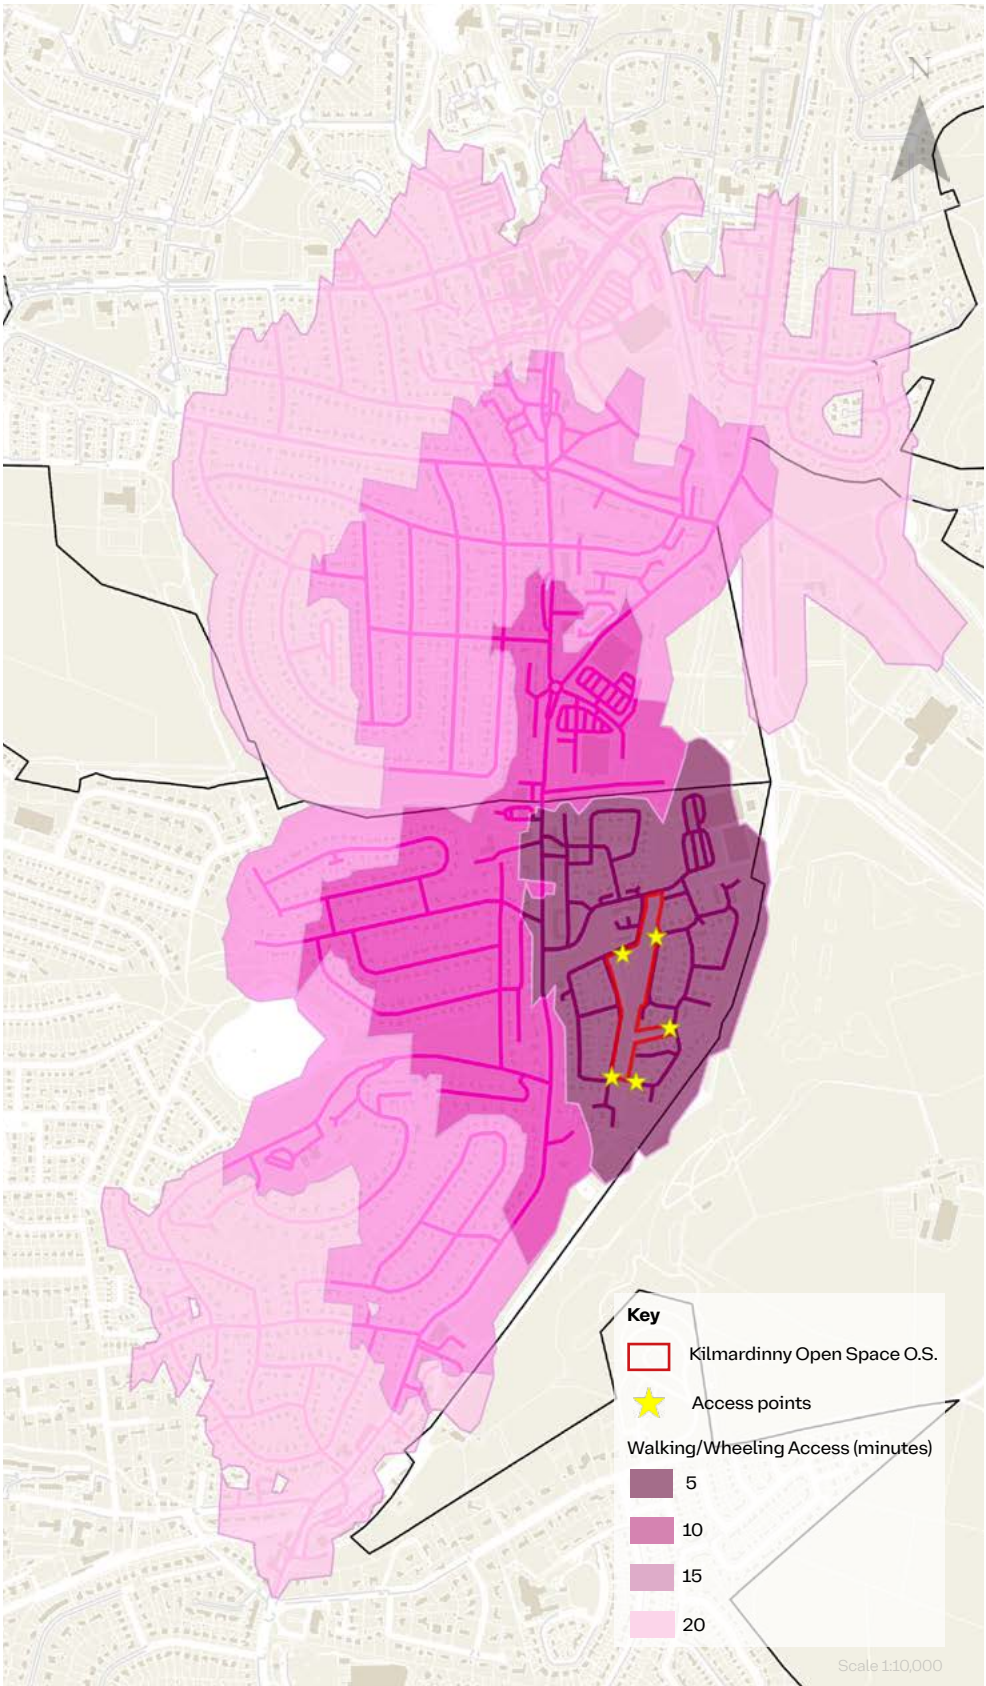
Figure 10. Kilmardinny Open Space Walking and Wheeling Access

These areas are well-served by the existing road and footpath networks. There is no connectivity to the east of the dark purple 5 min walking zone as this is Douglas Park Golf Club.

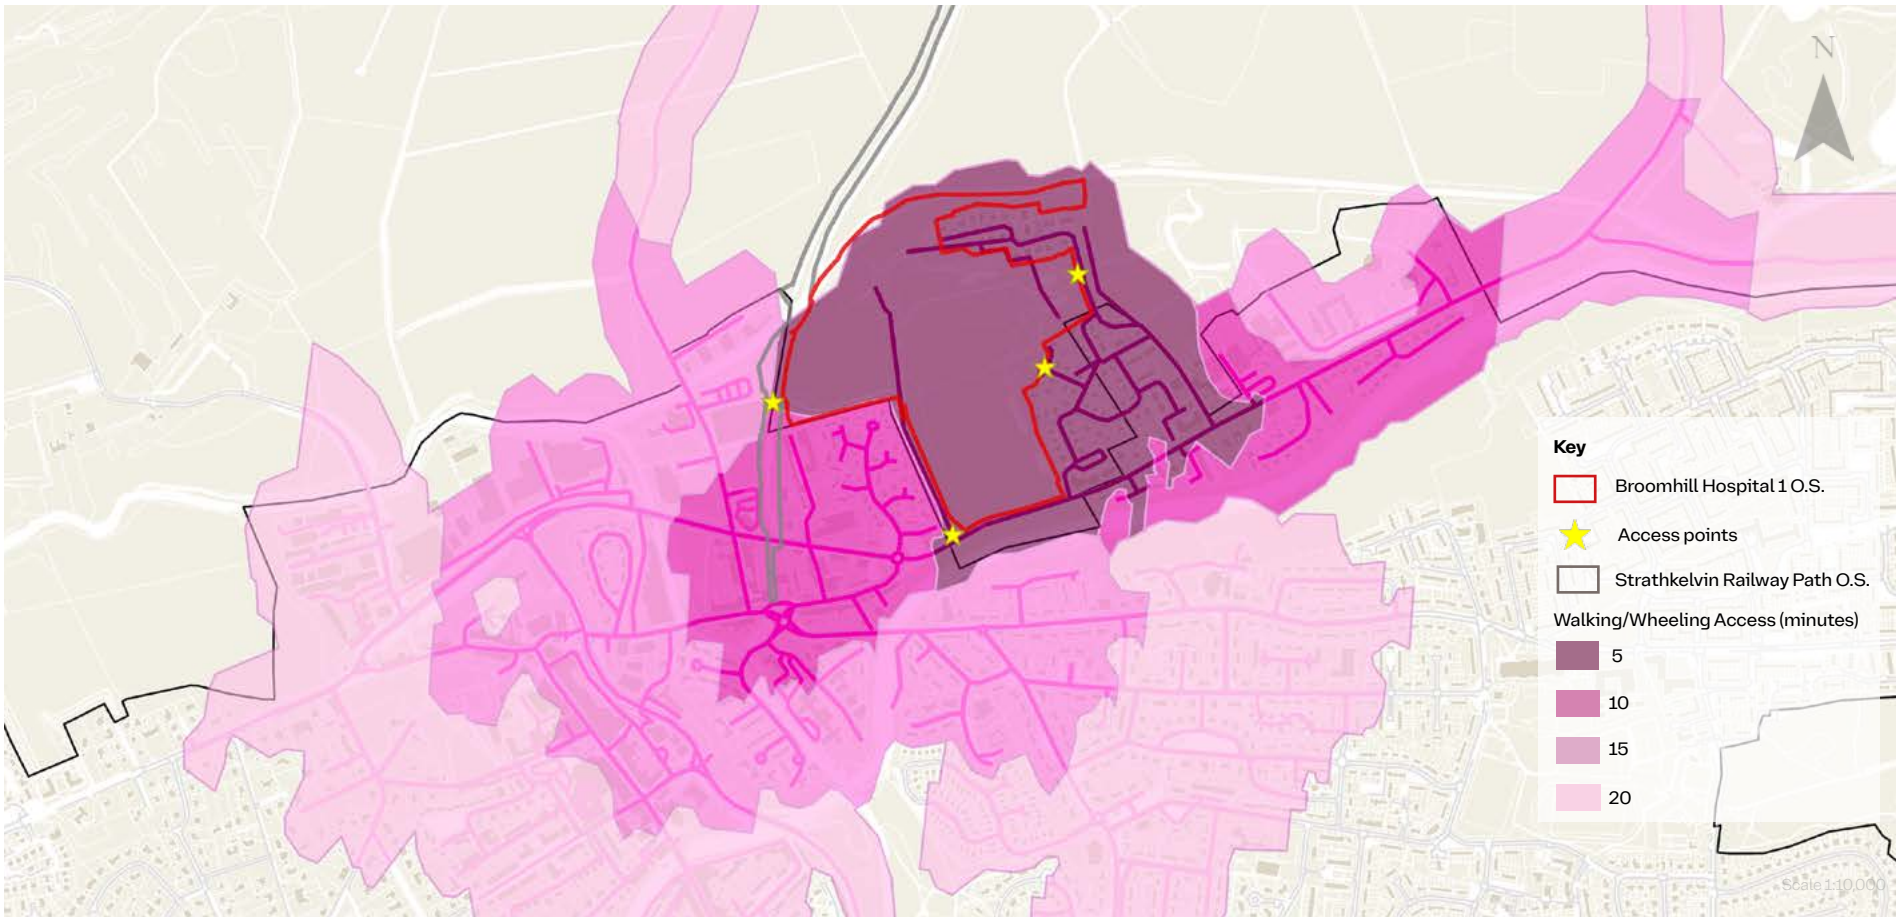
Figure 12. Broomhill Hospital 1 Open Space Walking and Wheeling Analysis

The walking and wheeling accessibility analysis for Broomhill Hospital 1 Open Space, shown in Figure 12, demonstrates strong connectivity to the surrounding new-build housing. Residential development on the former hospital site began in 2021, with associated open space (highlighted in red) provided to the west and southwest from lands off the former hospital.

These access points ensure that the open space is well-integrated into the surrounding network, supporting walkable/wheelable connections for both new and existing residents. The connection to the west and south west is somewhat good, with the Strathkelvin Railway Path offering a great link to the businesses to the west such as Lidl and Pro Bowl. This route enhances the site's integration with surrounding commercial areas and supports walkable/wheelable access for residents.

It is unclear whether residents in the south west at Kelvinvale Housing area have private access to the space through their back gardens. Walking and wheeling access along the northern edge is limited by the River Kelvin.

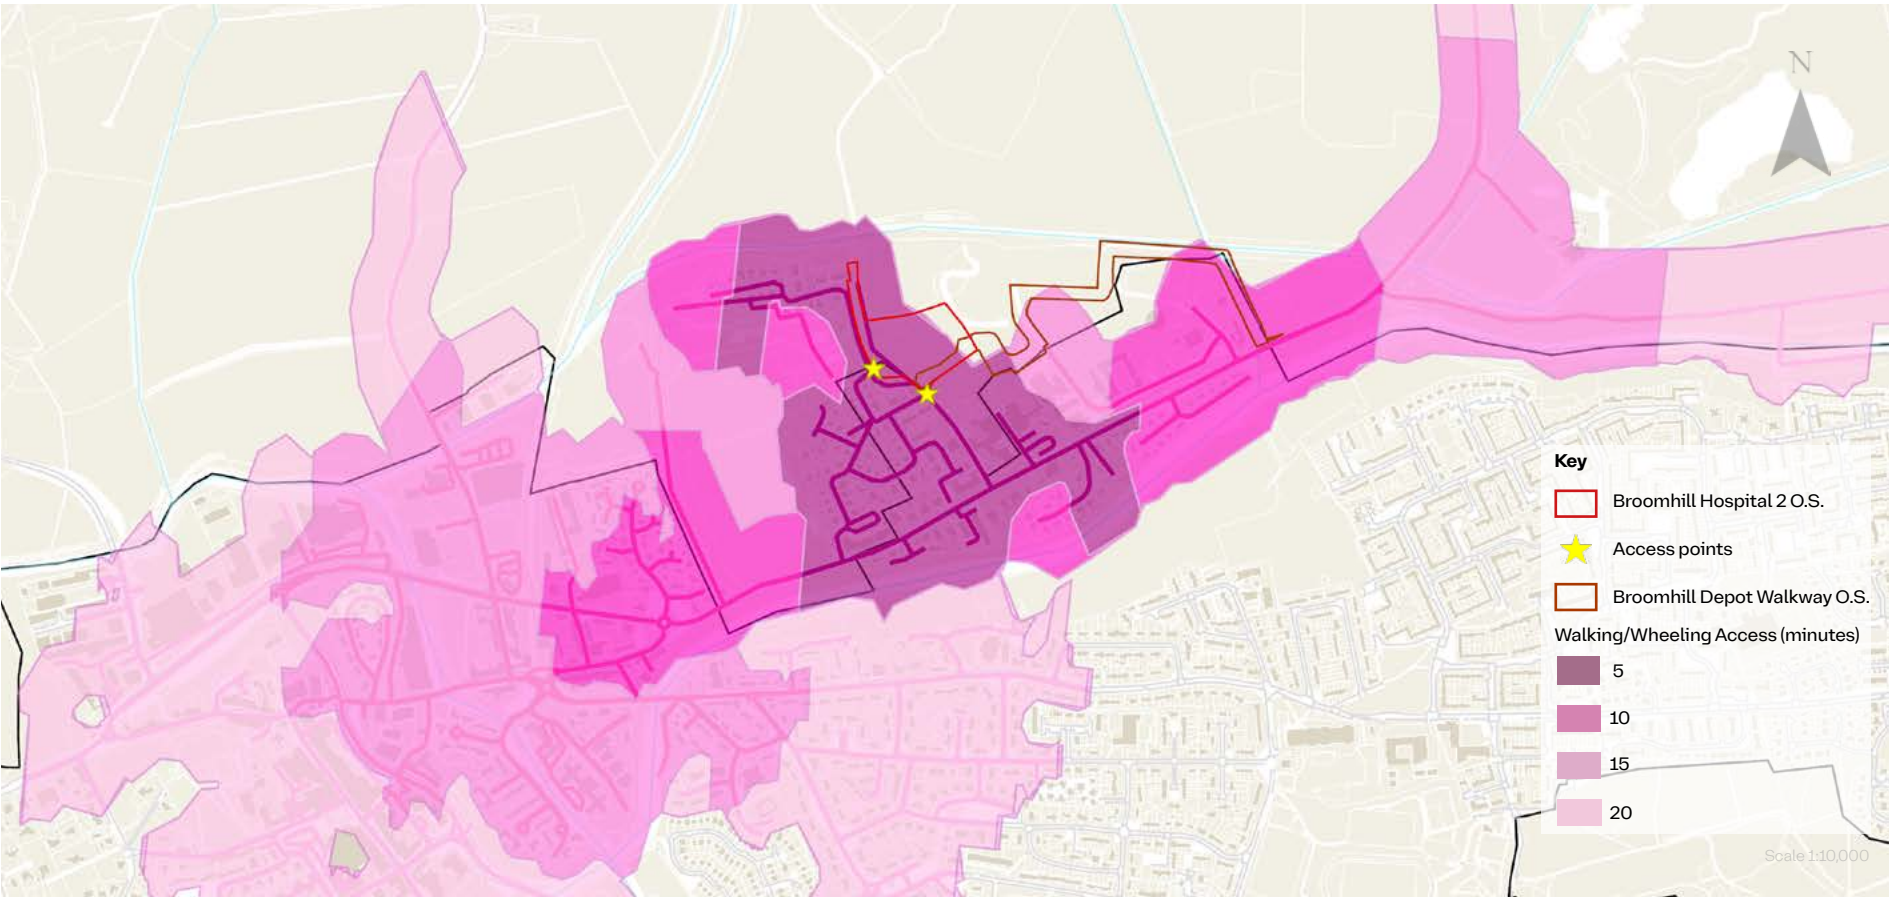
Figure 14. Broomhill Hospital 2 Open Space Walking and Wheeling Access

The walking and wheeling accessibility for Broomhill Hospital 2 Open Space can be seen in Figure 14, it is similar in its benefits its neighbour, (Broomhill Hospital 1) in that it serves the new local housing developments well, with access directly from the housing to the open space as highlighted by the access points in Figure 14.

The open space also connects to the Broomhill Depot Walkway Open Space (highlighted in brown), furthering access to this space and the connection of all four open spaces in this area (Strathkelvin Railway Path, Broomhill 1 & 2 and Broomhill Depot Walkway).

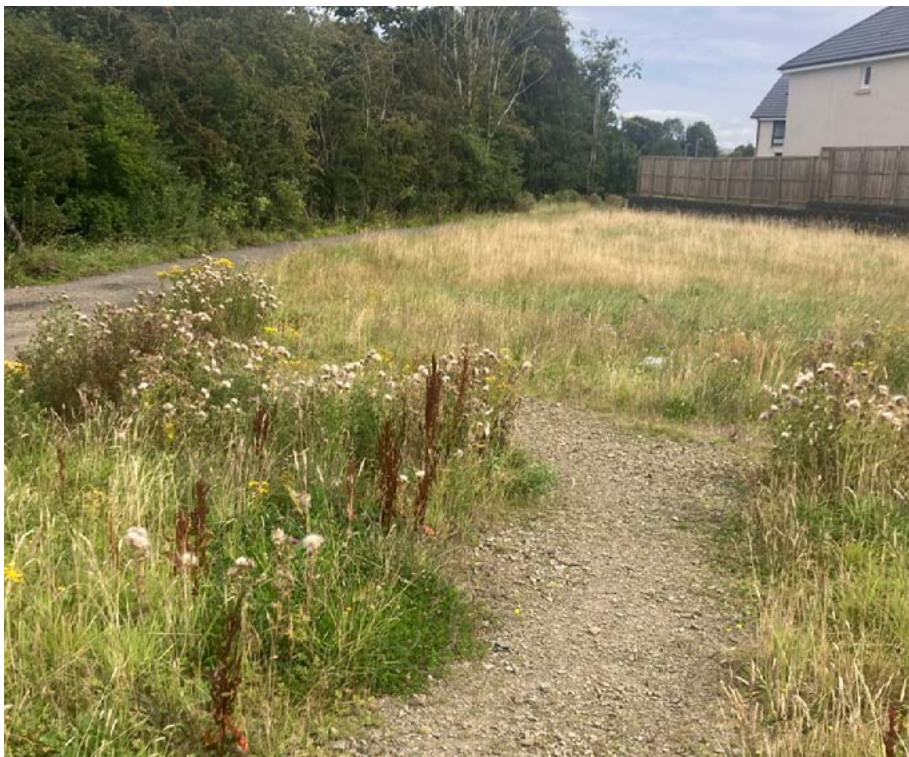
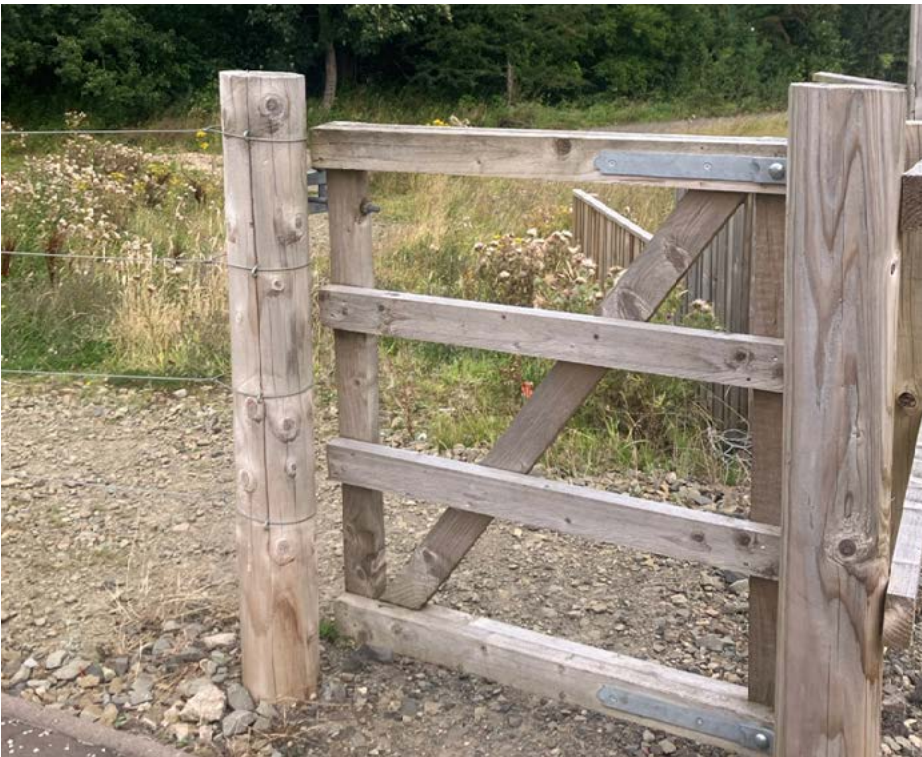
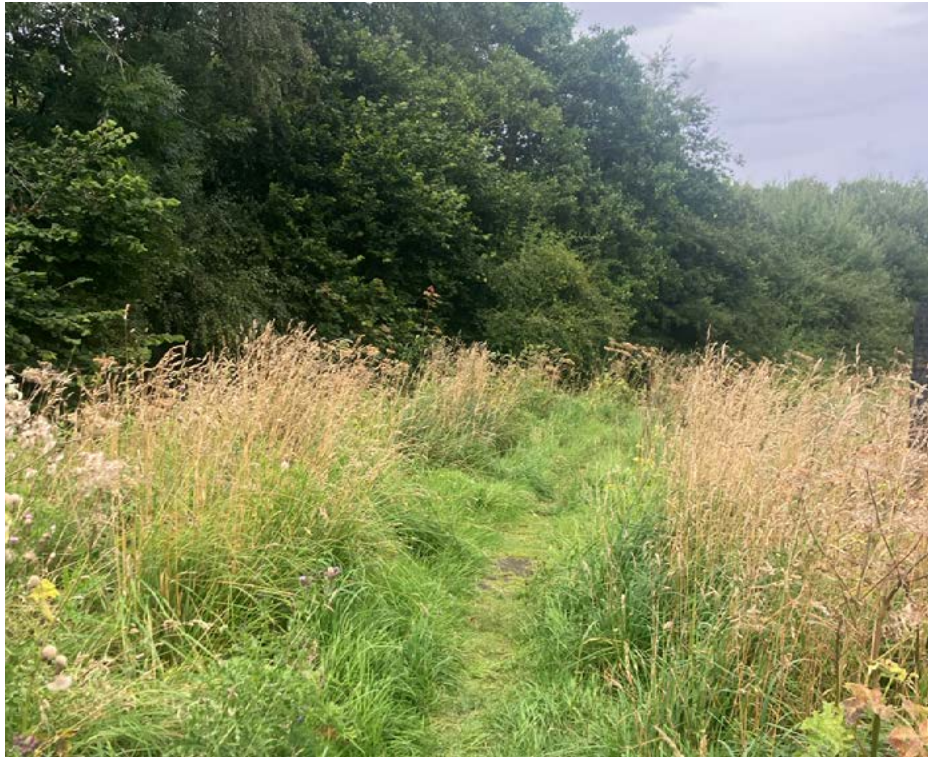
Figure 15. Broomhill Hospital 2 site photos

The paths (seen in the site photos in Figure 15) has informal paths with biodiversity relatively undisturbed.

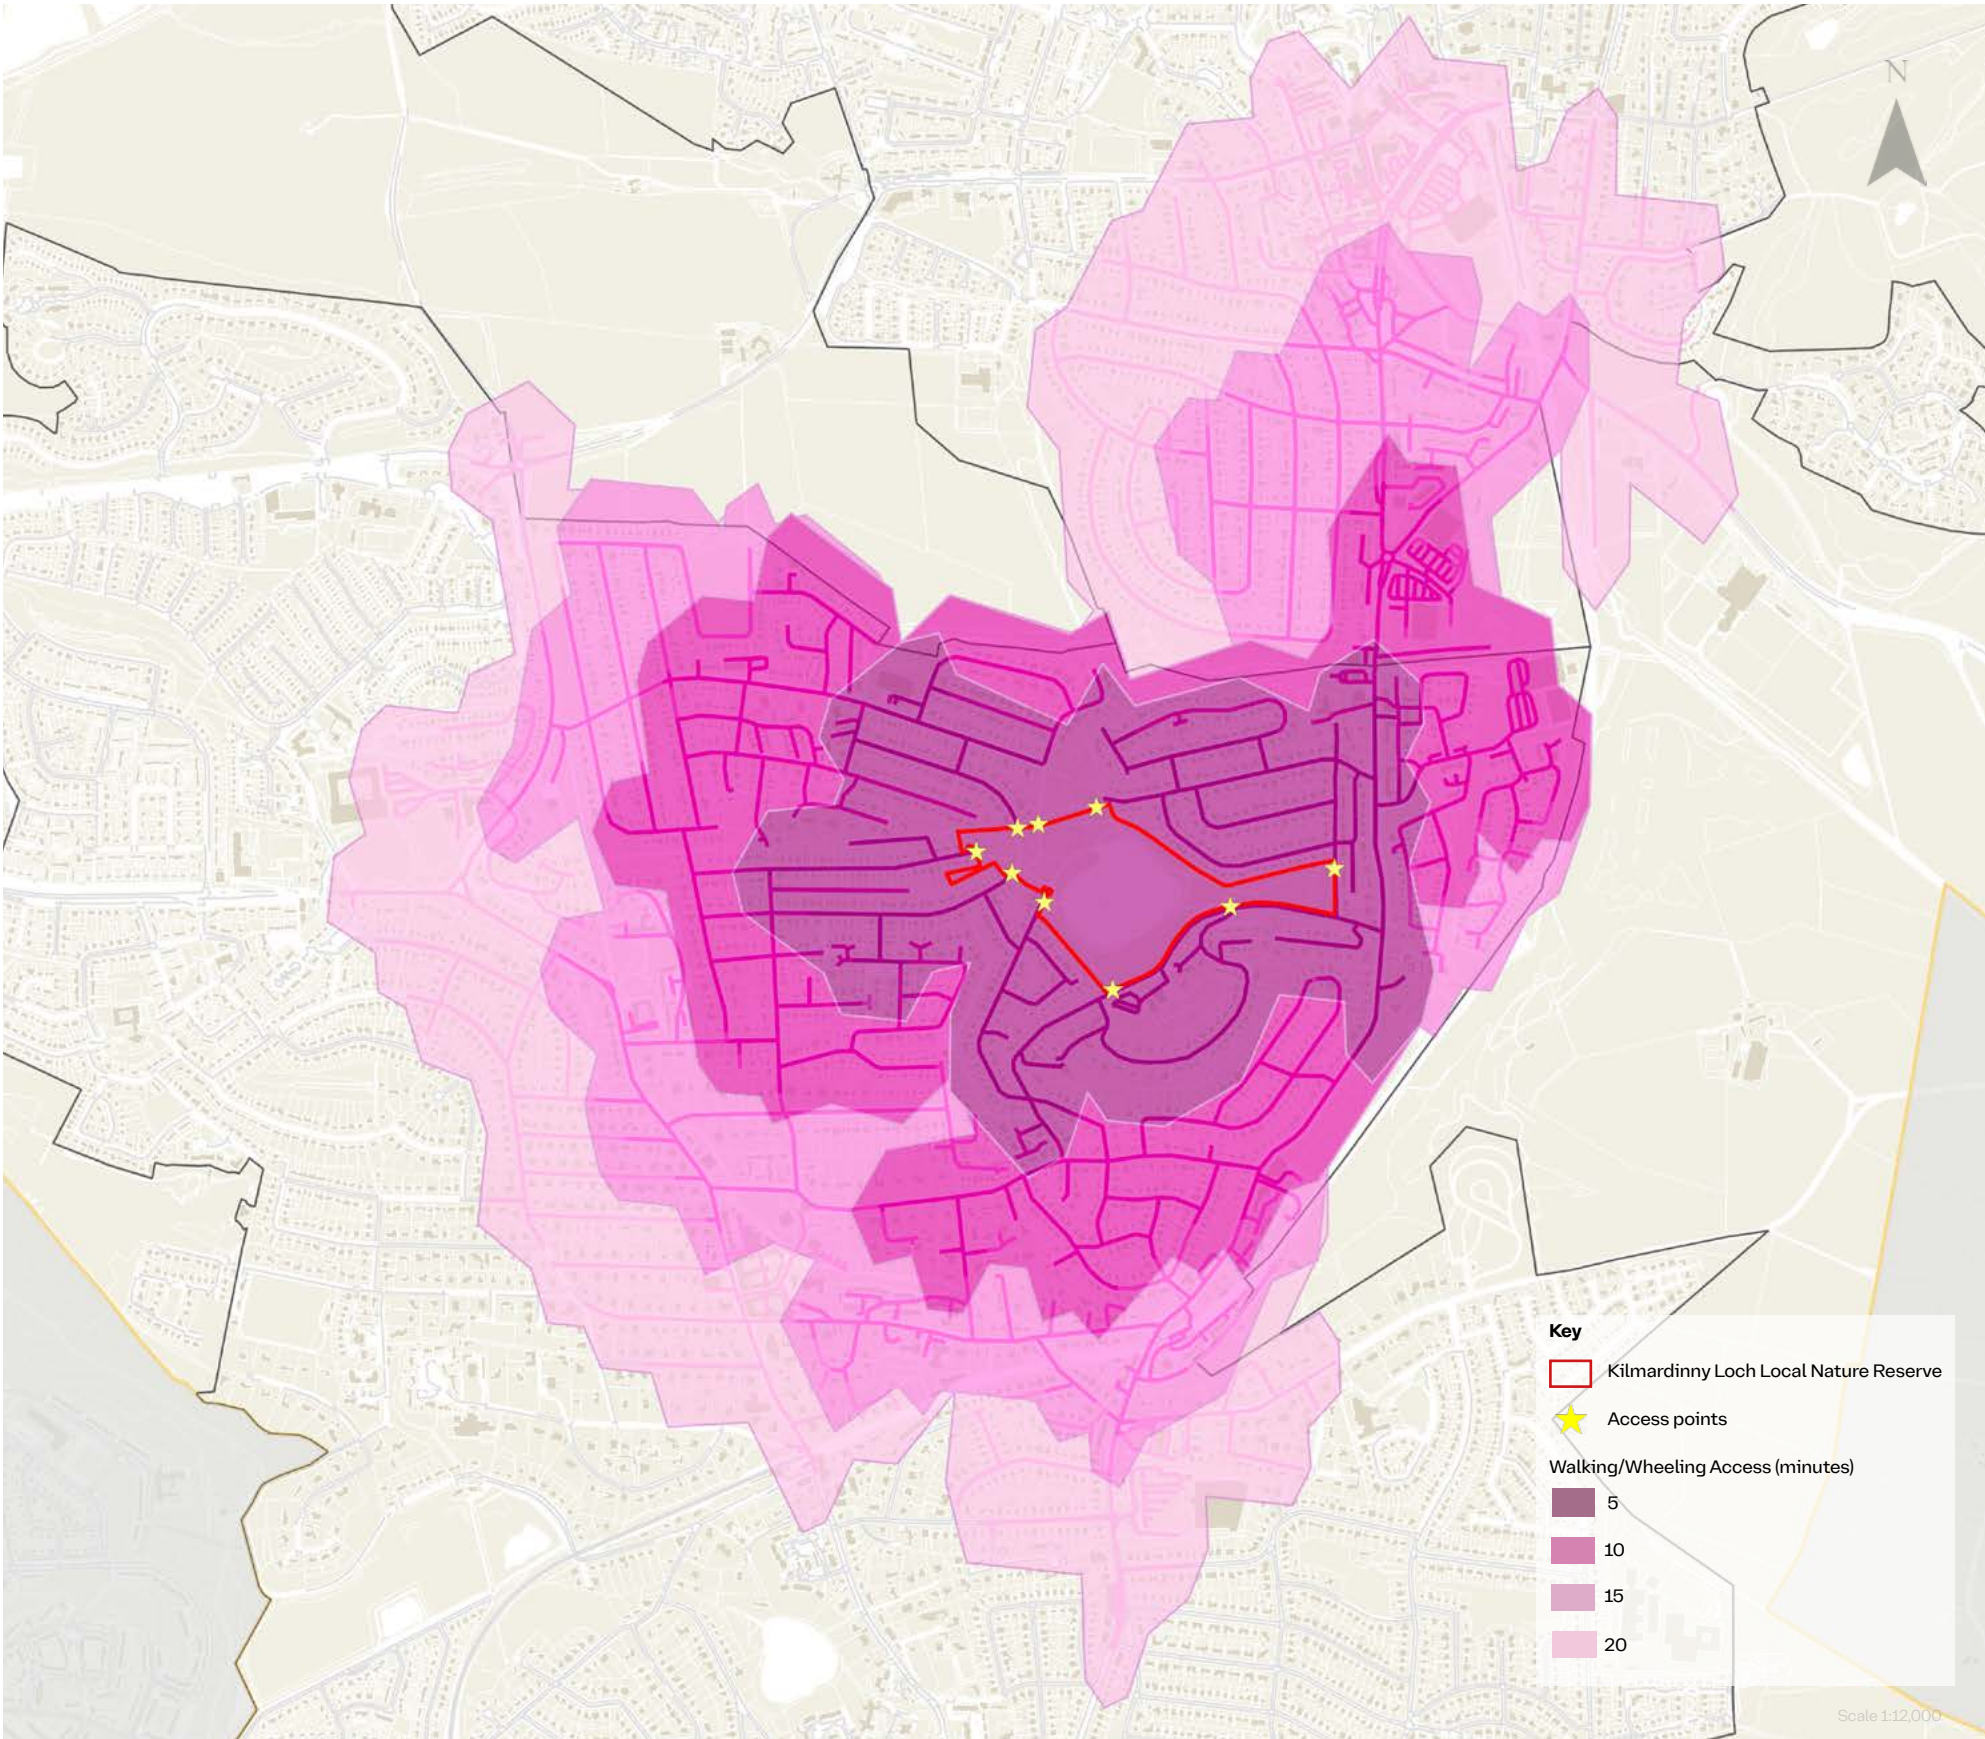
Figure 16. Kilmardinny Loch Local Nature Reserve Open Space Walking and Wheeling Access

The walking and wheeling accessibility for Kilmardinny Loch Open Space can be seen in Figure 16. Located close to Kimardinny North (Figure 10), this is a well established open space in Bearsden and is close to Milngavie.

Kilmardinny Loch demonstrates strong connectivity to the surrounding housing estates in Bearsden. It acts as a central semi-natural open space for local residents and visitors to the area. It is accessible by seven access points with good connectivity to the Kilmardinny and Mosshead Play Area to the north of the site. Paths are in good condition and support walking, wheeling and cycling access, while limiting disturbance on woodland and wetland habitat.

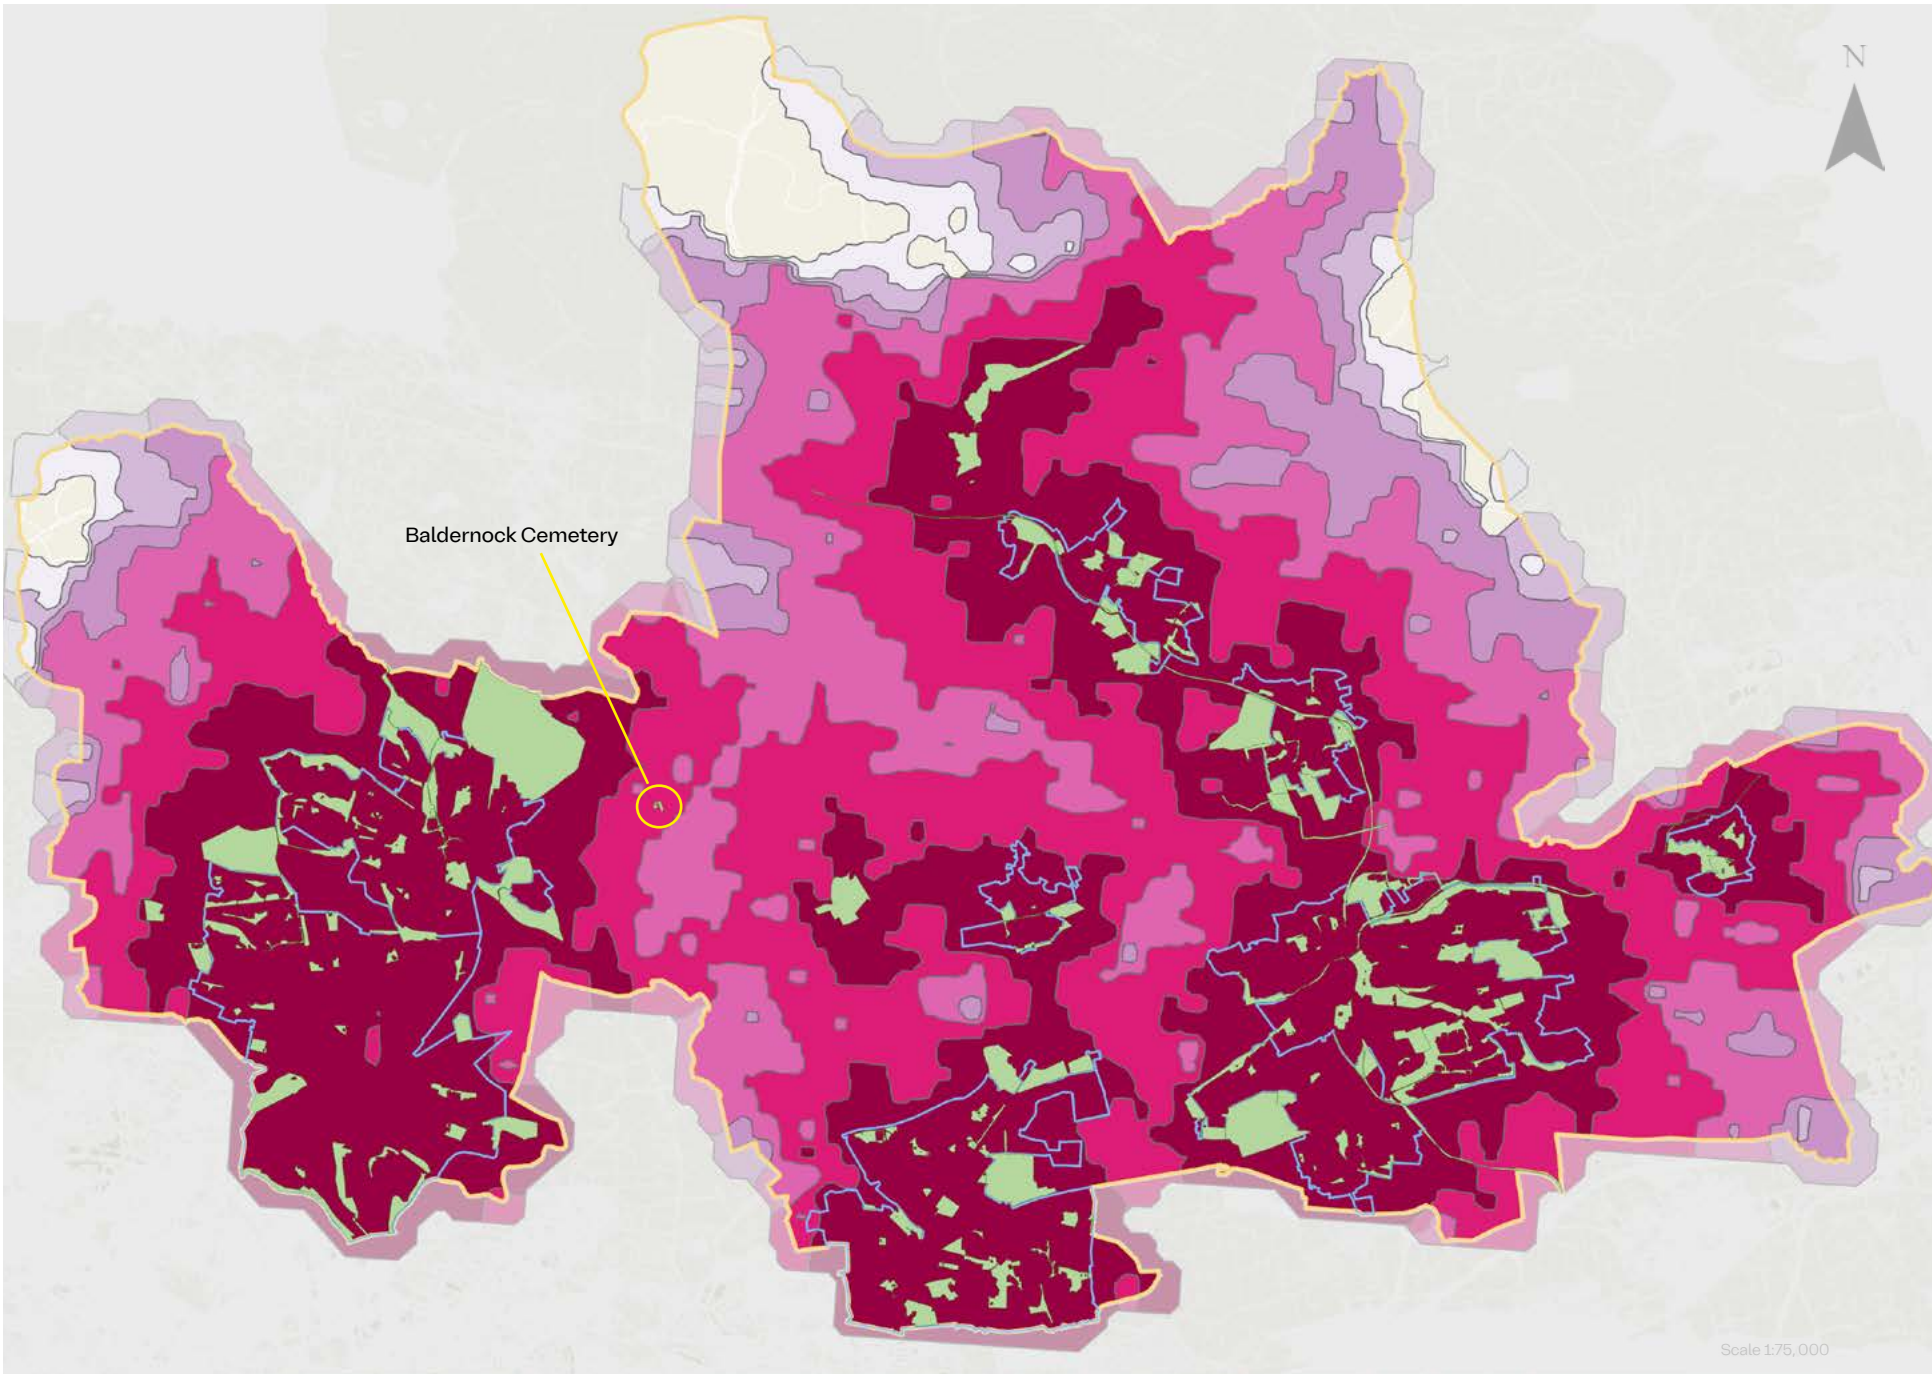
Figure 17. Cycling Analysis to Open Spaces within East Dunbartonshire

In addition to accessibility scoring, the isochrone map provides a clear visual representation of the time required to reach open spaces within East Dunbartonshire. This analysis confirms a high level of connectivity across East Dunbartonshire, illustrating that most open spaces are easily accessible by cycling.

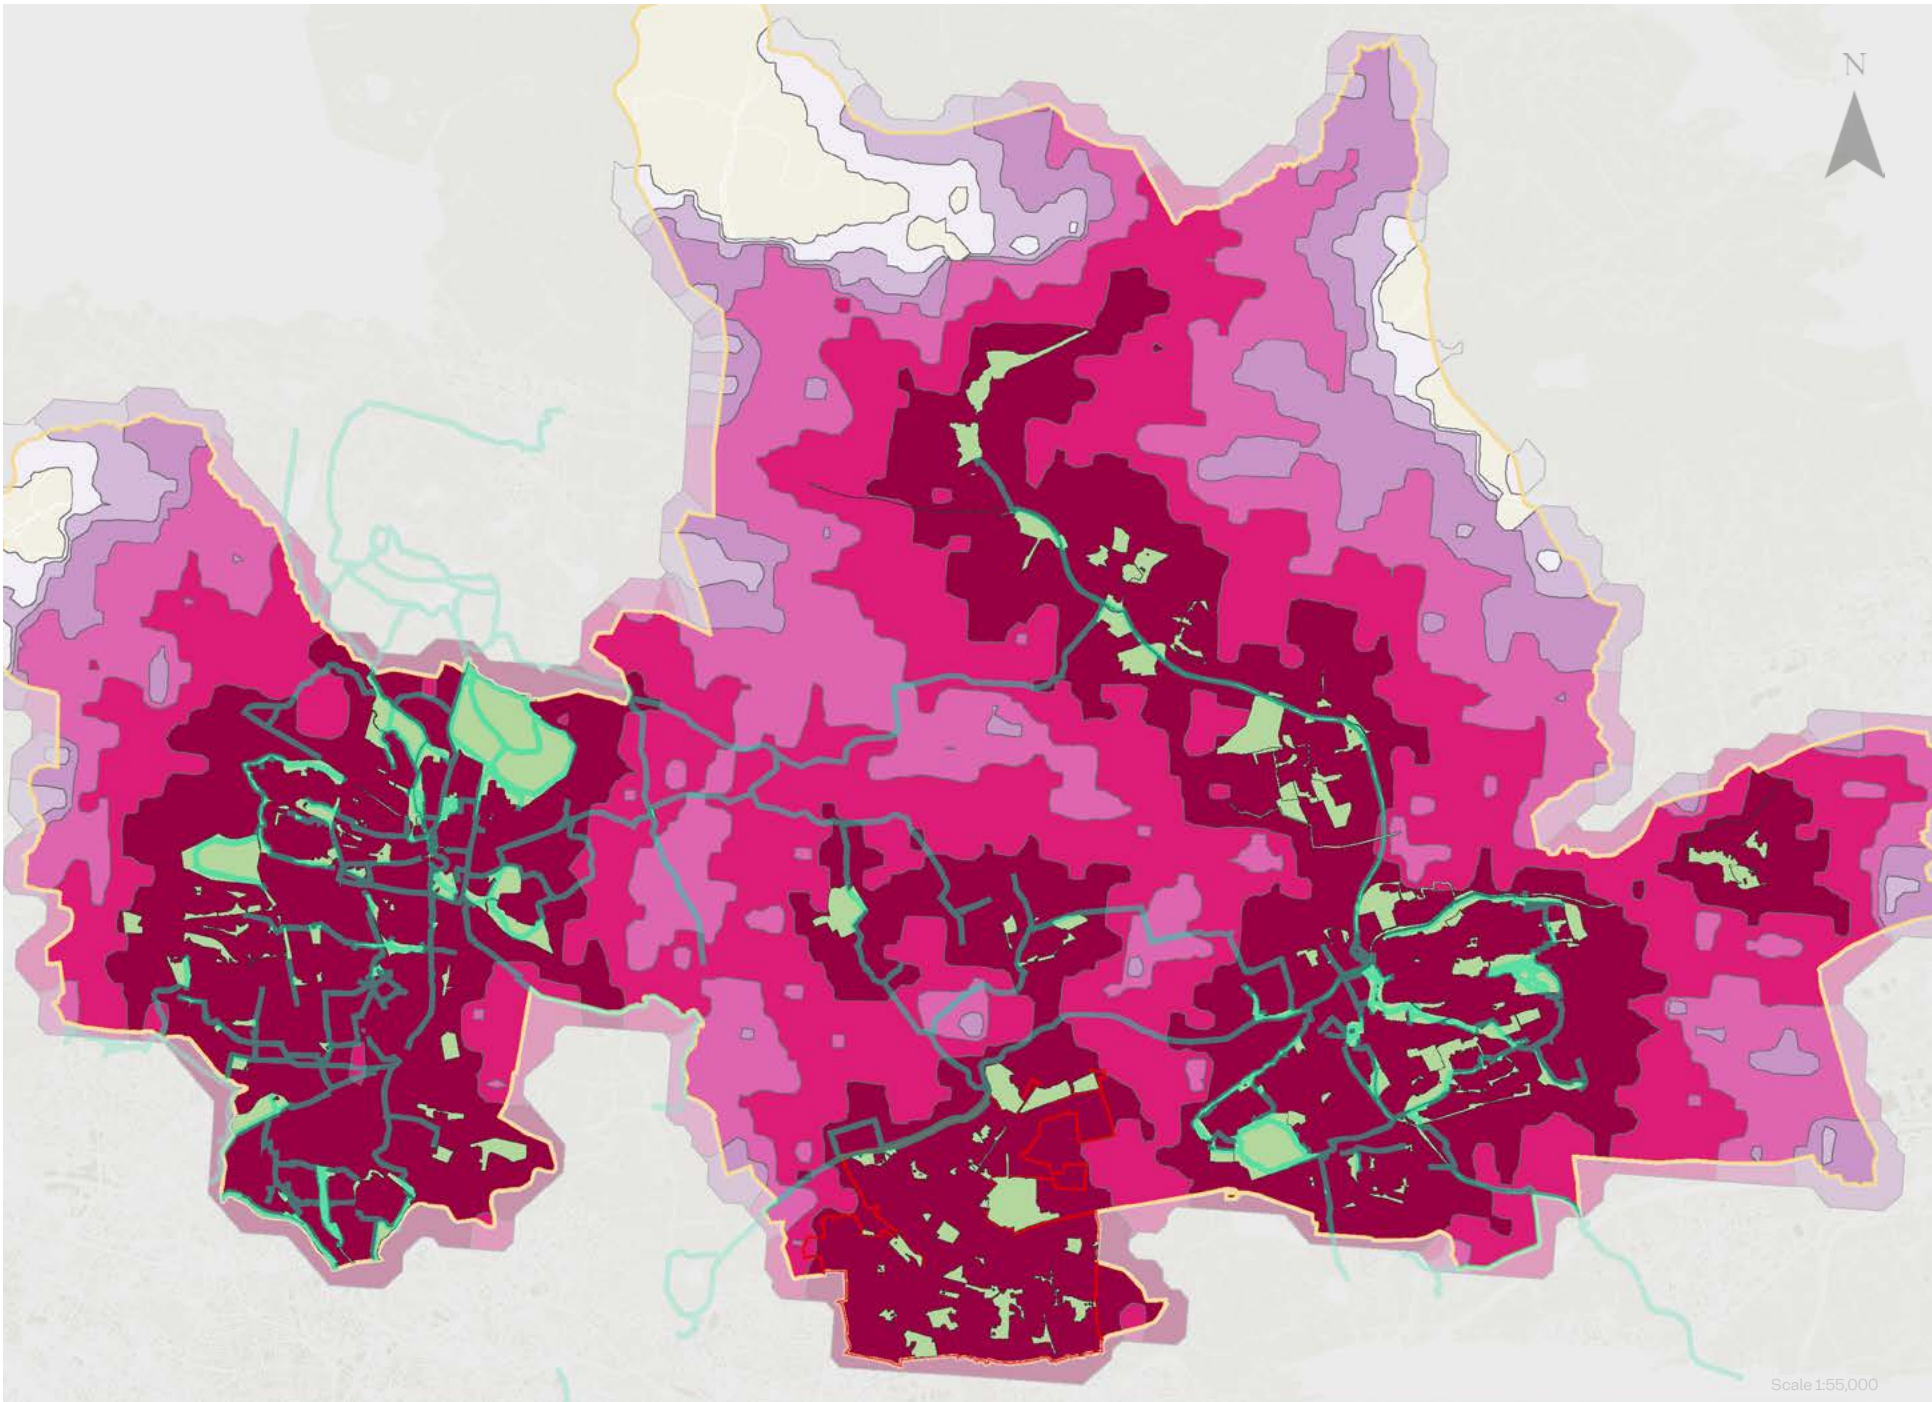
The figure also highlights that Baldernock Cemetery, highlighted in the previous Figure 17, is along the recognised ‘quiet on-road route advisory cycle lane’ as highlighted in [EDC’S Walking and Cycling document](#).

Bishopbriggs, the second-largest settlement in East Dunbartonshire by population, shows good access to open spaces by the cycle network, particularly in the north, open spaces to the south are better served by the existing road and path network, indicating weaker connectivity using the cycle network.

- EDC Cycle Network
- Up to 5minute cycle
- 5-10 minute cycle

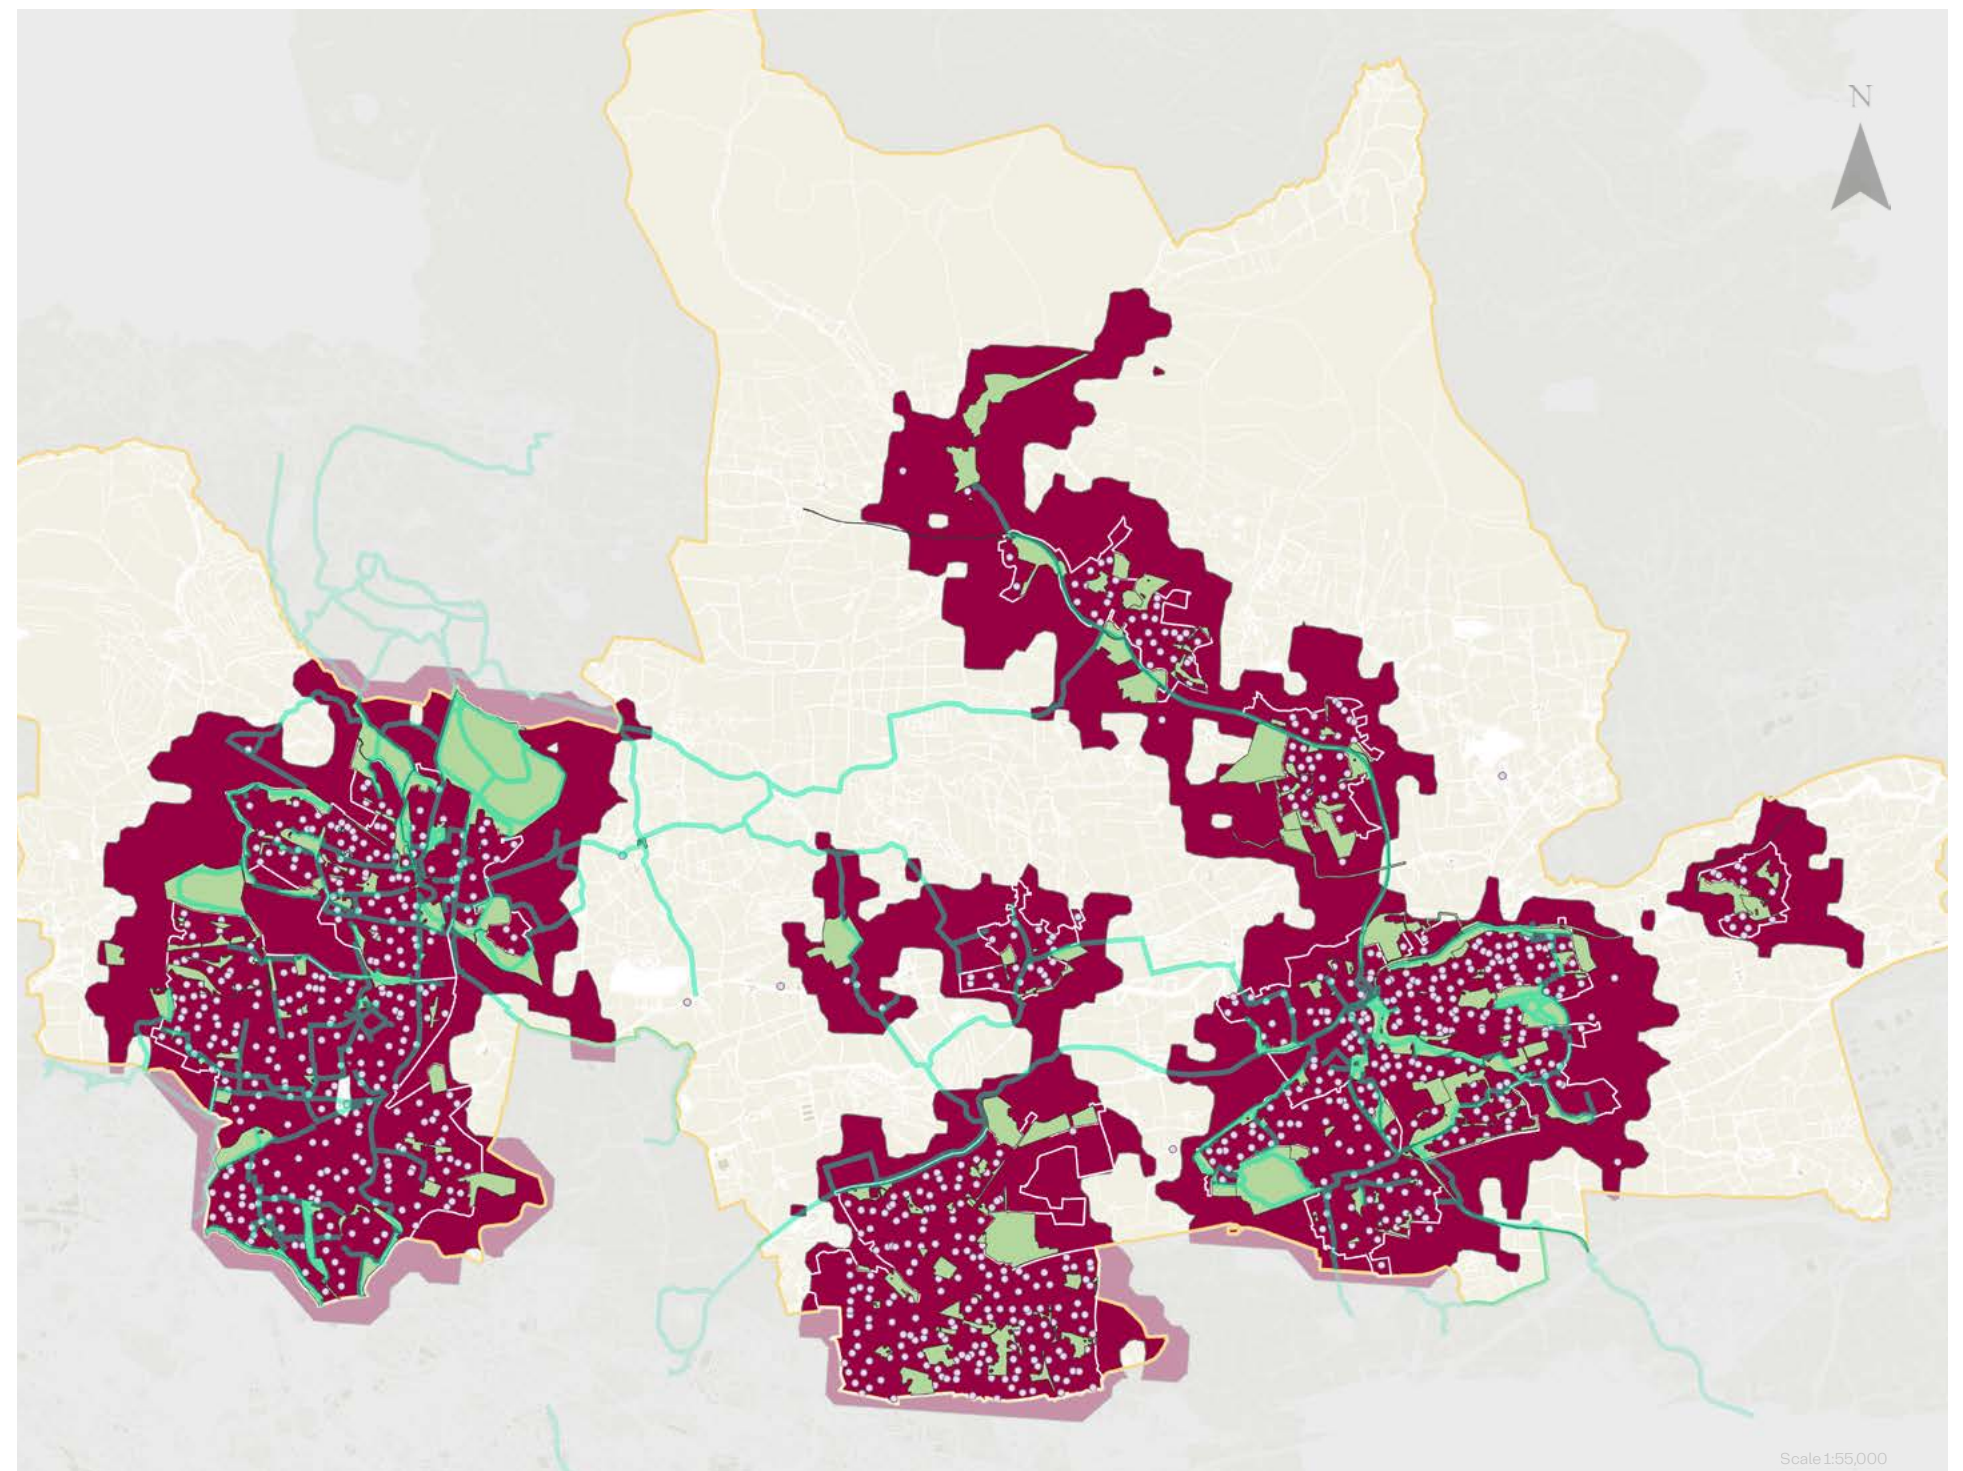
Figure 19. Cycling Analysis with Cycle Network and Population Centroids East Dunbartonshire

Cycling accessibility to open spaces plays a key role in promoting active travel and equitable access to green infrastructure. To ensure the analysis reflects actual settlement patterns rather than just geographic spread, NRS Census 2022 population centroids are have been overlaid on top of the cycling isochrones as seen in Figure 19.

Figure 19 shows the cycling access 'up to 5 minutes' along with the cycle network and NRS Census 2022 population centroids. This helps to highlight where population centres fall outside the threshold of a 5 minutes cycle to open spaces.

A few settlements lie outside the 5-minute contour, but still fall within the 5–10 or 10–15 minute bands, suggesting that while not immediately adjacent, they are still reasonably accessible by cycling. These are around the areas of:

- Balmore - Village
- Bardowie - Hamlet
- Baldernock - Parish
- Auchenreoch - Hamlet
