# East Dunbartonshire Council

## Open Space Audit

2025

| Document Type | Audit Report |

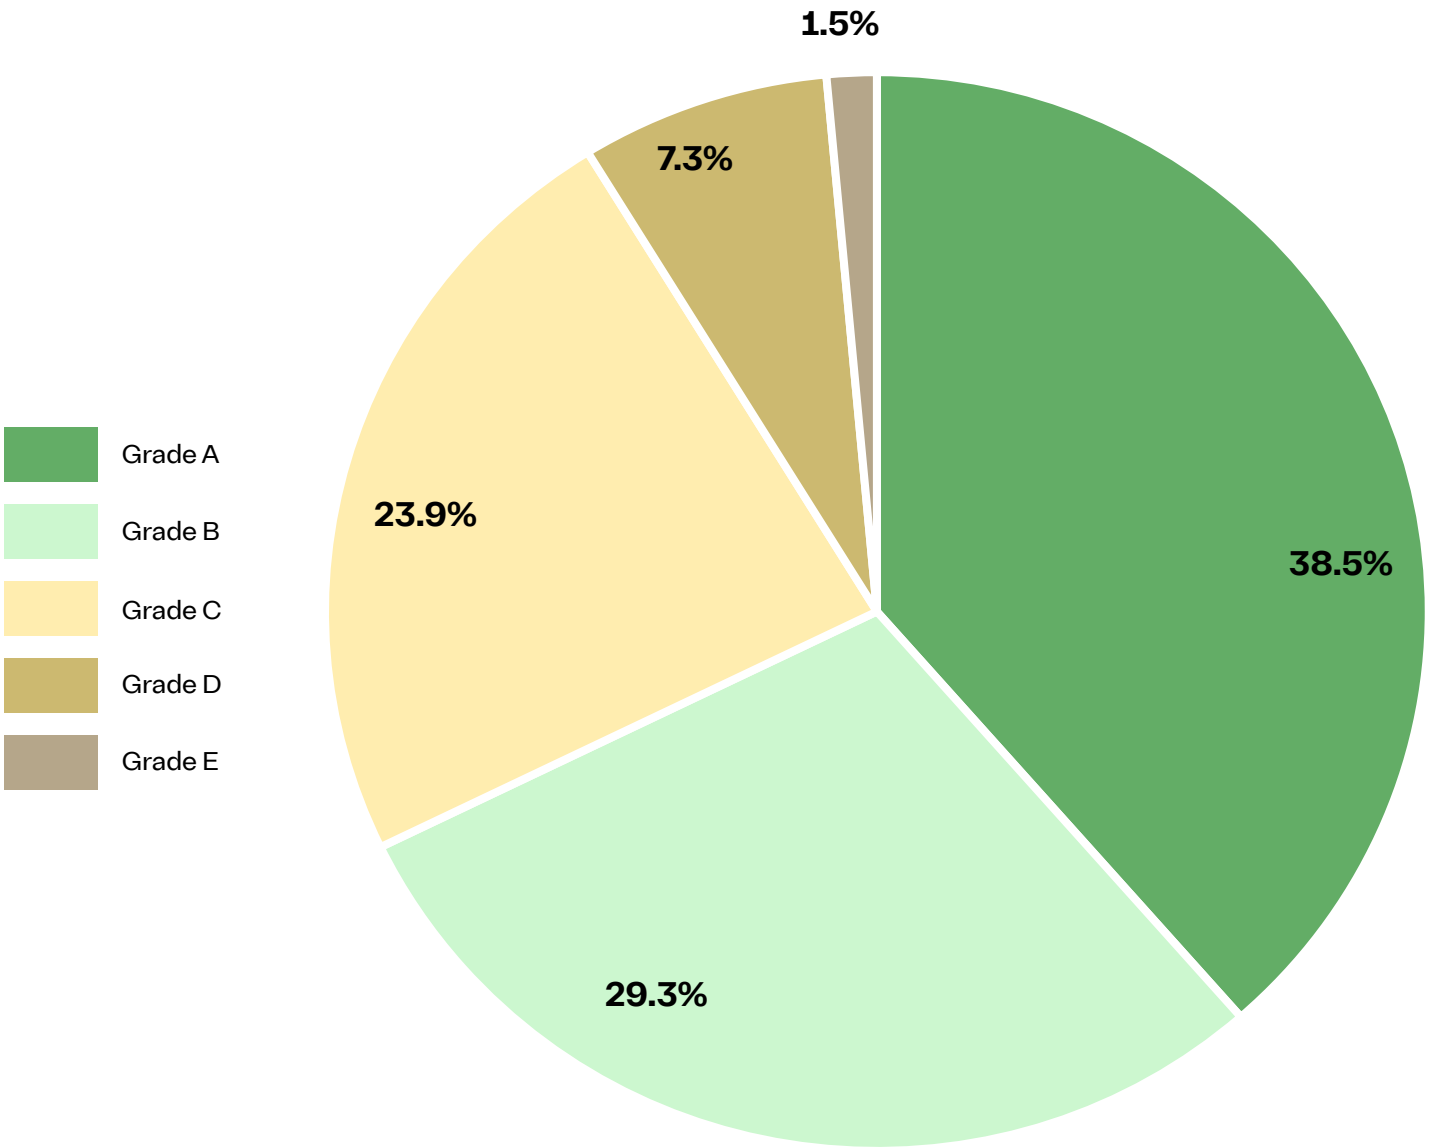
Figure 20. Quality Analysis proportions by Grading

The average quality of Open Space in East Dunbartonshire is high with the majority of sites achieving an A or B score and only 17 sites of 204 failing to meet the standard by scoring D or E. Specific issues and opportunities identified by the survey are broken down by locality in detail over the following pages.
