Appendix 3 Site Audit Written Assessment

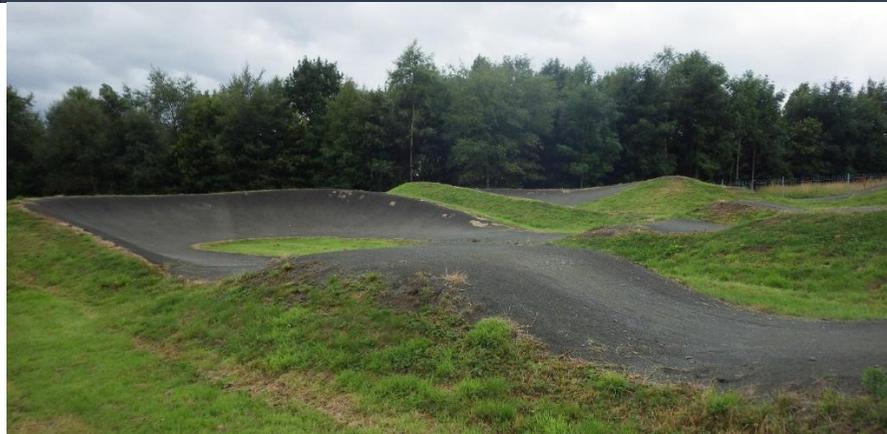
B/M 011

Langfaulds Field is a large area of open space, on the western extents of Bearsden, with a fenced BMX track to the west of the open space. The track is comprised of tracks made of whindust with grassed mounding. There is a whin dust path network around the park.

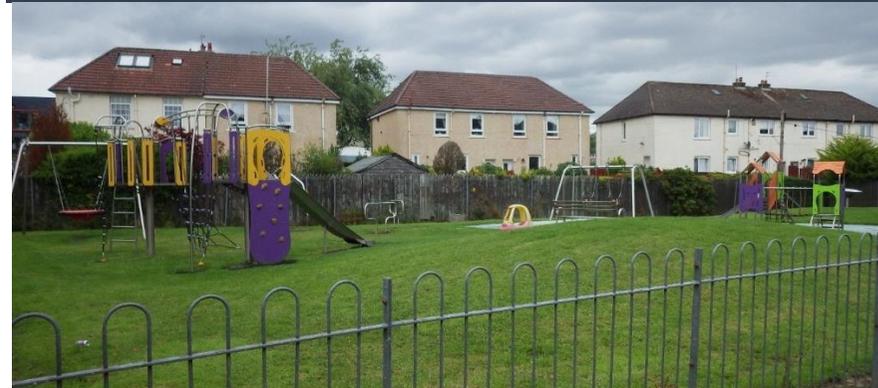
B/M 012

Small play area tucked in a small open space in the heart of a residential area. The play space is accessed along a narrow connecting path from 2 residential areas. The play area is fenced, has one gated area and is a combination of wet poured safety surfacing and grass matting in amongst an area of mown grass with earth mounds. The play area is overlooked on all sides by housing. There are 2 benches and a bin. There are pieces of play equipment within the grassed area with grass safety matting underneath. The play equipment comprises: accessible roundabout, stepping stones, dish roundabout, toddler climbing unit, cradle swings, basket swing, older children's climbing unit, 2 bouncers and roundabout. The play area will probably provide a well used neighbourhood play space.

No action necessary. Ensure that the path leading to the play facility is in good repair. Improve the setting of the play facility through amenity tree and shrub planting and boundary improvements.

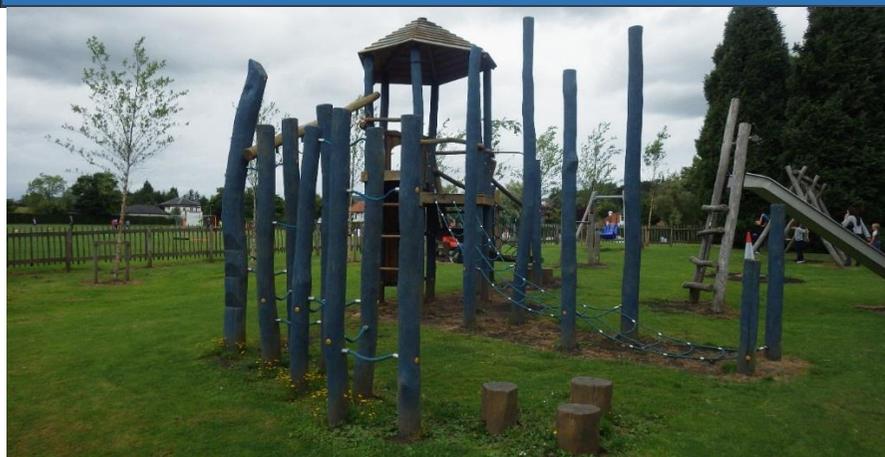
B/M 016

Play area located to the south east corner of Thorn Park, adjacent to a sports pitch and a pavilion. The site can be accessed along a path running along the eastern side of the sports pitch. The play area is set in an attractive wooded landscape. The play area is located in a relatively secluded location, at a distance from Thorn Road but is overlooked by nearby houses. The play equipment is a range of wooden products, with wooden structures and plastic/ metal fixings. The play equipment provides a range of play opportunities for toddler and primary school aged children. There are swings, basket swing, climbing units, slide, inclusive swing, balance beams. There is a bench and 2 bins. The safety surfacing is grass matting set within the mown grassed area. The play area provides a range of play experiences, set within an attractive open space. The play area will probably provide a well used neighbourhood play space.

The play area is currently fit for purpose. The paths have been recently repaired.

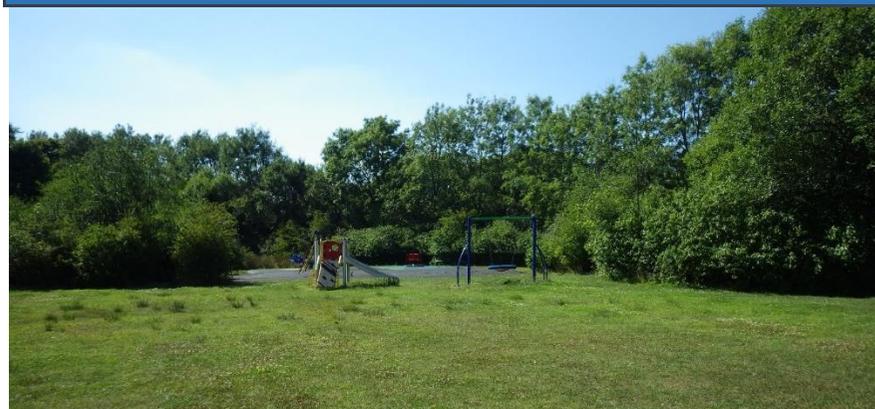
STR016

Small play area located to the rear of Bishopbriggs Sports Centre. The secluded location and lack of entrances and overgrown access paths probably limits its use. Westfields Road is fenced and therefore access to the play area is not possible. The play equipment is set within a bitmac area, with safety matting set on top of the bitmac. There is a bench and a bin. The play area caters mainly for toddlers and young children. The equipment comprises: a slide, basket swing, swings, seesaw, spinning pole and a roundabout. Some of the sections of matting are lifting, creating trip hazards. The play area is not overlooked and is in a relatively isolated position. The location and poor access to the play area, along with the uninteresting play offer, would suggest that the play area is not well used.

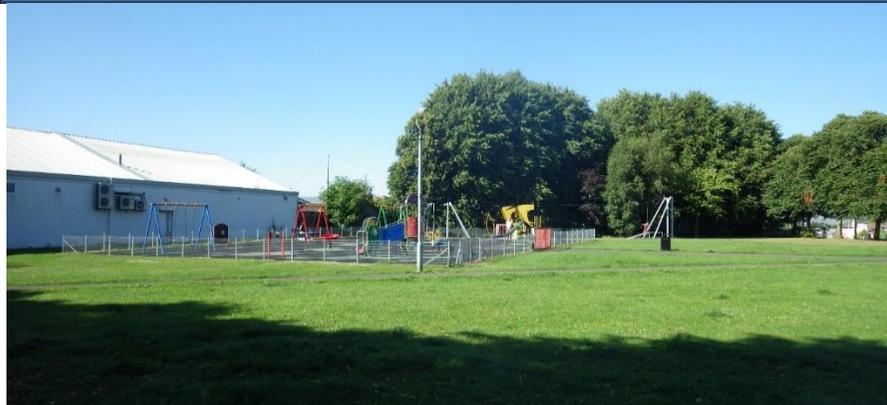
STR019

The fenced play area is located in an area of open space, set in an area of grassed open space, surrounded on all sides by houses, just off Cloan Crescent. The play area is connected to the wider path network by bitmac paths that cross the park. The fenced play area is located to the rear of a retail unit. The play area has been recently installed and provides a range of play equipment within a fenced area. There is a zip wire in the open space adjacent to the play area, where there is lots of space for informal recreation and play. The safety surface is wet pour surfacing, with a pirate theme. There is 1 bench and 1 bin. There are swings, roundabouts, play panels, hop scotch, bouncers and climbing units for younger and older children, a surf board and spinning poles. The play area provides a range of play equipment for a variety of ages, set within an attractive wooded park.

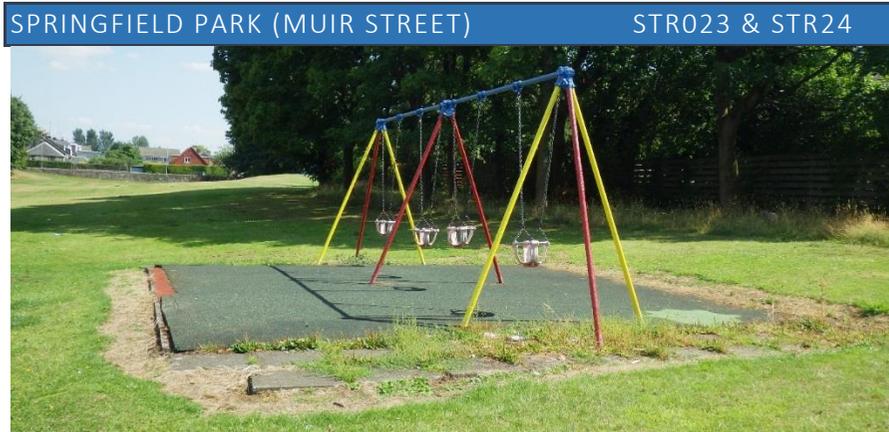
Springfield Park is a small rectangular park with 2 separate areas of play equipment. There is an older play area located to the west of the park, which includes play equipment for toddlers set within areas of safety surfacing and matting (STR023). The equipment includes: swings, 3 climbing frames, toddler swings and a frog. The equipment is dated and past its best and does not provide an interesting play experience. The safety surface is weedy at the edges and former play surface is visible round the edges. Wet poured safety surfacing has been installed under the swings. This play space is probably not well used.

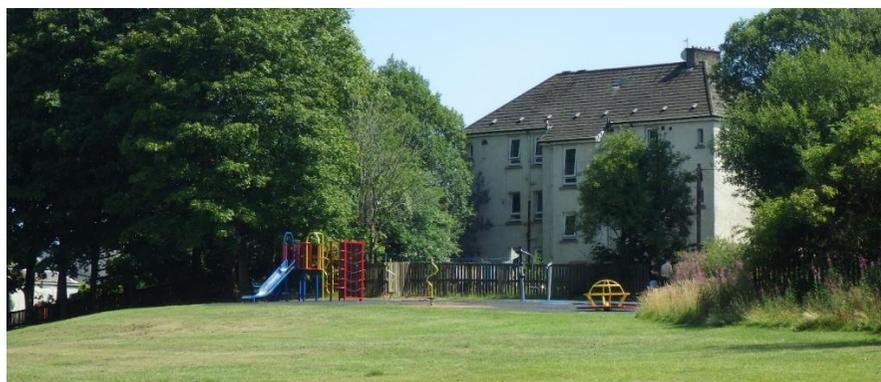
The other play area is closer to a row of houses but may be an area that attracts antisocial behaviour (STR024). This space is accessed up the grassy

slope or along a narrow alleyway from Springfield Square. There is also a stepped access from Callieburn Road. The play area has been recently installed, it comprises: climbing frame, 2 turning poles, roundabout, surfing balance equipment, small character seat, fitness equipment and a bench. The safety surface is plastic matting on top of a bitmac surface. The fitness equipment has been fairly recently installed, with an area of wet pour safety surfacing. There has been attempted/ setting lighting to the safety surfacing. The play area is located in a relatively secluded location as is not visible from car drivers along Springfield Road due to the hedge, or by the adjacent houses.

Monitor the condition / levels of anti-social behaviour of the Callieburn Road play area to ensure that the play facility remains fit for purpose. The entrances to the park should be reviewed and redesigned, to encourage the park to be better used by local people to increase levels of natural surveillance. Consider removal of the eastern play area and use for flood mitigation (depending on upcoming flood modelling for Bishopbriggs). However, elements of natural play could be introduced for younger children e.g. wooden features encouraging exploratory play, utilising the topography of the park.

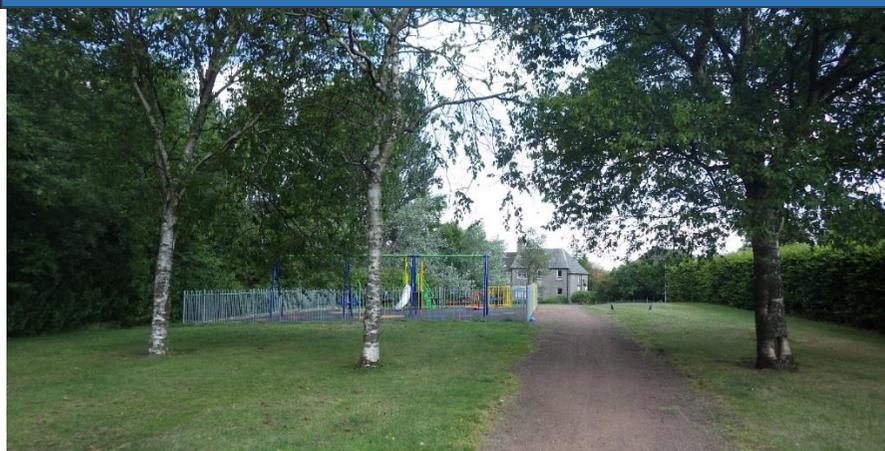
STR025

Recently installed play area, set in a large area of open space. An old play area has been removed. The new play area is closer to Callieburn Road. The play area is fenced and contains swings, basket swings, 2 bouncers, roundabout pole, slide, roundabout and tunnel. There is a bench and a bin. The surface is wet pour safety surfacing. The use of the facility is probably limited to toddlers and young children. Access from the park to the west is across sloping grass or up to a steep slope / poorly maintained set of steps with handrail.

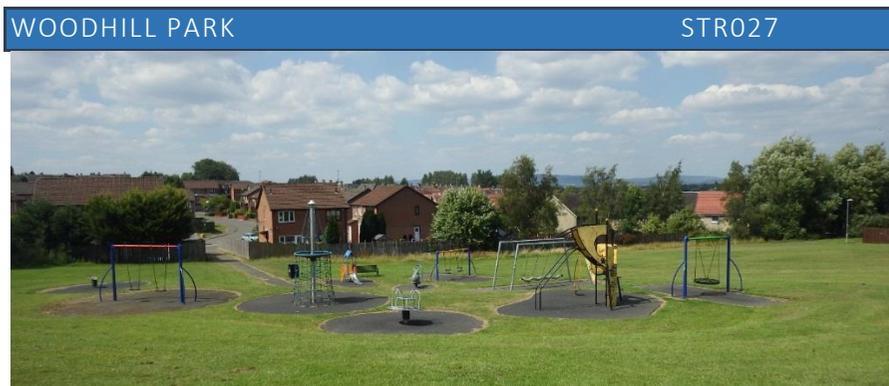
Play area set in the corner of a large park, on a sloping site and adjacent to a grassed football pitch. The play area is built on 2 levels, joined by 3 sets of wooden sleeper steps with concrete treads. There is a path up to the lower play area and access from O'Neill Avenue. The play surfacing is islands of wet pour surface, edged by concrete edging and set within a grassed area. There is 1 bench and 1 bin. The equipment for toddlers comprises: a small climbing frame and slide, swings, a bouncer and talk tubes. The play equipment for older children includes: a rope swing, swings, roundabout, climbing rope, roundabout, basket swing, a climbing frame and a surf board.

Some minor works to ensure that the play facility remains fit for purpose. Upgrade in the long term. Extend the play opportunity on the wider open space site through exploratory play and trails, circular path routes, amenity tree / shrubs, seating areas and bulb planting. The area is included in the Masterplan for Woodhill & Etive parks, which seeks to improve the landscape and biodiversity value of both parks and links them through a network of active travel routes. Consider providing areas for personal exercise through natural play and adult fitness.

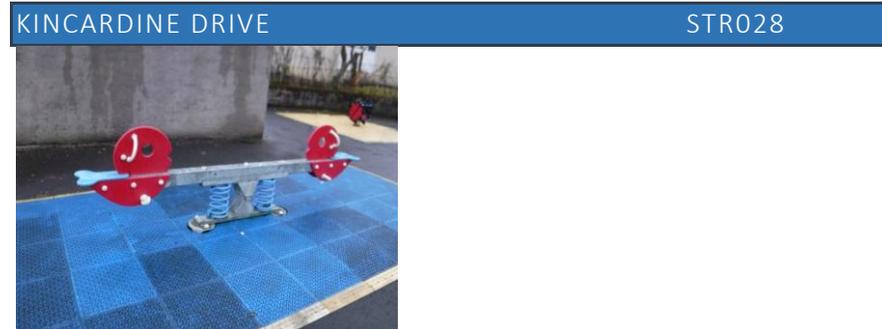
Small play area tucked between the adjacent residential properties and a garage area. The site is mainly bitmac surfacing, with areas of grass matting mounted on top and areas of wet poured surface. There are 2 sets of swings (cradle and flat), see saw, rocker, rotator and dish roundabout.

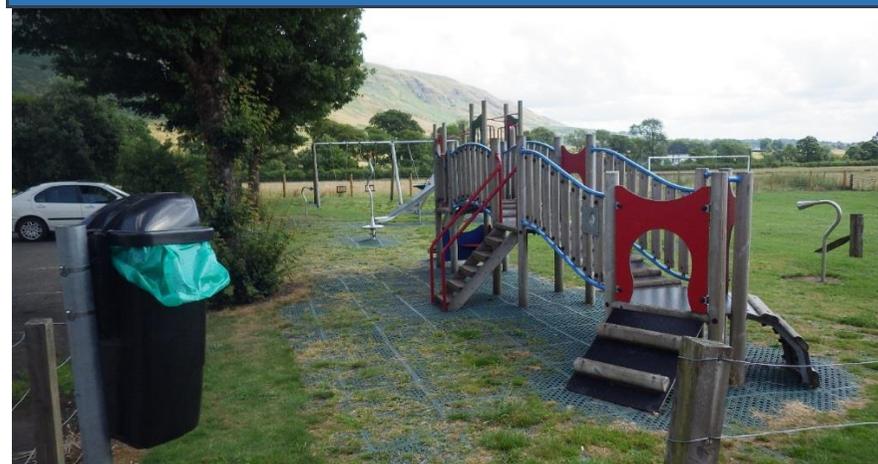
STR036

An attractive play space, located off the main street, beside a village hall and a car park, on the southern edge of village. It is located in a lovely rural location, overlooking wooded hills and adjacent agricultural fields. The play area consists of: swings/ basket swings, climbing structure, 2 bouncers, roundabout, tunnel, see saw, toddler climbing frame. There is one bench and 1 bin. The play equipment has robust wooden frames and stainless steel equipment with coated boards. The equipment is in good condition, though some sections of wood may require treatment. The safety surface is grass matting. Some sections of the matting are lumpy and uneven but appear to be in reasonable condition. There is a football field adjacent to the site. The boundary fence is a post and wire fence, with 2 entrances.

No action necessary. Though, some sections of wood forming part of the play equipment may require treatment. Repair / replace the boundary fence as necessary.

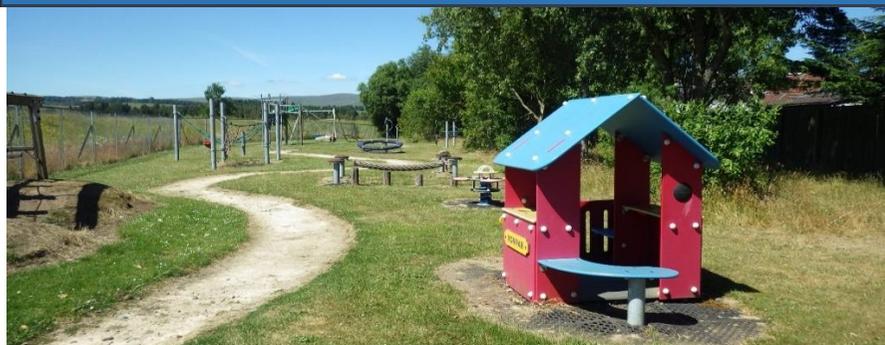
STR049

Linear strip of open space located at the western edge of Kirkintilloch. The play area provides an interesting “trail” of play and fitness equipment, providing a wide range of play experiences. The play area is more informal in character, with pieces of play / fitness equipment set within a grassed area. The play area appears to have been fairly recently extended, but the old play area remains. This older section comprises: a swing and a rocking seesaw. There are 3 areas of grass matting, one without a piece of equipment. The upgraded section is a trail of pieces of play equipment and tree trunk benches along a winding narrow loose bound path. There are climbing structures for older primary school aged play equipment and lots of smaller climbing / stepping activities for younger children. The play equipment is set in areas of wet pour safety surfacing. The play area is not fenced, apart from the boundary fencing of the adjacent gardens / farm land. There is only one entrance off Adamslie Drive. The play area, though full of interesting play equipment, though may not be as well used as it should due to its hidden location on the western edge of a residential area.

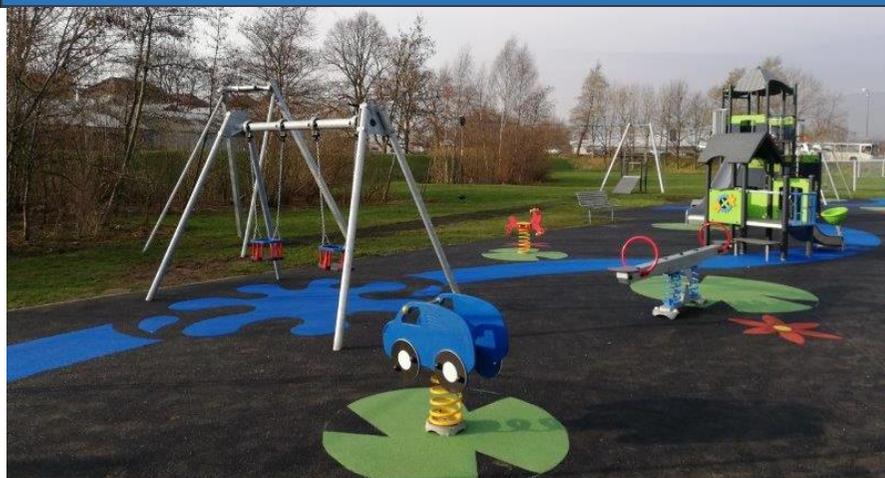
STR051

The play area is located in a large area of open space, just off the High Street alongside the river. The play area is located alongside the spinal bitmac path that provides access through the open space. The play area is not fenced, but has mature trees around the perimeter and open grassed areas for informal play and recreation. There is a football field close to the play area, which is grassed with metal fencing on 3 sides to keep balls off the path and the busy road. There are 2 benches and 1 bin. The play space has recently been replaced, with basket swing, carousel, somersault bars, climbing unit, spinner bowl, playhouse with slide, springles, seesaw, toddler swings and a cableway. The equipment is set in areas of wet pour safety surfacing cut into a bitmac area. There is also a nearby wooden sculptural garden with wooden seats shaped like rabbits and hens for toddlers. The surrounding park appears to be a bit run-down and not in a great location, next to a river, a busy road, industrial units and some flats, pedestrian through route.

The play area has recently been replaced.

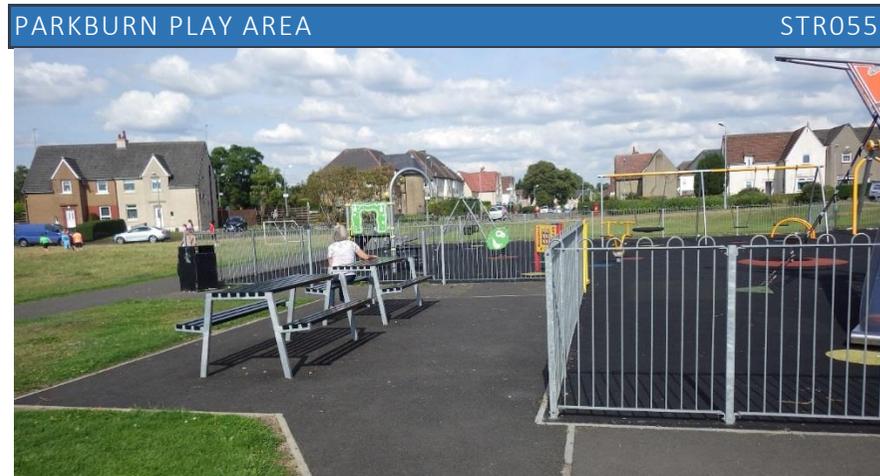
Large fenced play area, set within a large area of open space, and surrounded on 3 sides by housing. There is a blaes football pitch and mown grassed areas, which will encourage informal play and recreation. The play area is relatively recently installed and is fenced with 2 entrances. The play equipment comprises: flying fox, swings and basket swing, toddler swings, 2 bounders, toddler climbing structure, seesaw, roundabout, older children's climbing structure. The surfacing is wet poured safety surface. There are 2 picnic benches and 1 bin just outside the gate. There is a basketball court and a bench close to the play facility. Also, a bike practice area marked out on the bitmac surface adjacent to the play area.

No action necessary.

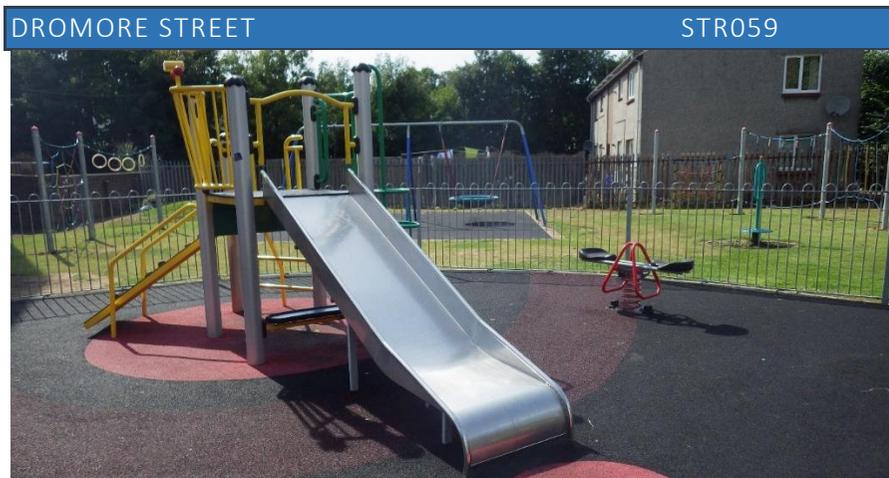
Small fenced play area set in an area of grassed open space, surrounded on all sides by houses, just off Dromore Street. There are 2 distinctive zones of play, one within a fenced area and pieces of play equipment set within grassed areas outwith the fencing. The play area within the fencing is recently installed and provides play opportunity for toddlers and younger children, comprising: climbing unit, basket swing, cradle swings, bouncer, see saw, slide and a roundabout. There are 2 gates and wet poured safety surfacing. The equipment in the grassed area comprises: swings and basket swing, 2 climbing structures, roundabout and a trampoline. There is 1 bin.

The play area is currently fit for purpose and the play equipment is of high quality and condition.

The quality assessment reflects the location in a small site, surrounded by houses, without much landscaping. The overall landscape quality of the site should be improved with amenity tree and shrub planting and boundary improvements.

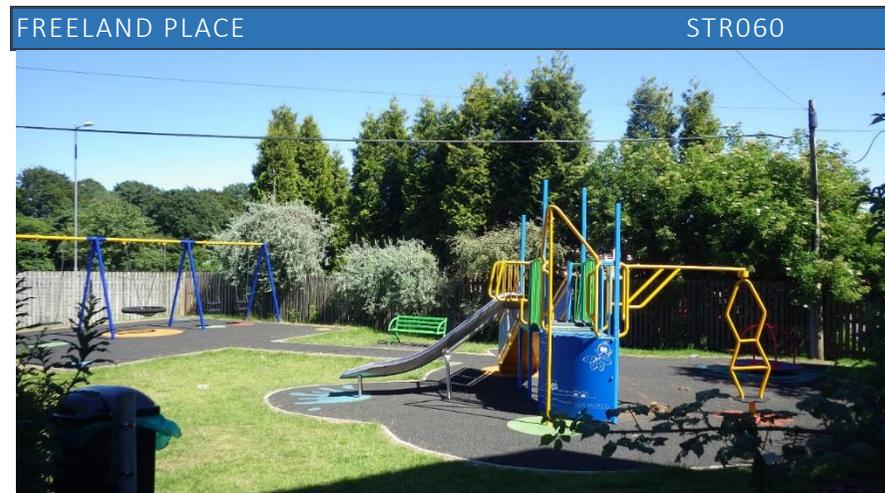
The play area at the corner of Freeland Place has been recently installed. The small open space is entirely in use as a play space for younger / school aged children. The open space is enclosed by boundary fencing, preventing access to the adjacent busy road and residential housing. Pieces of play equipment are set within an area of wet poured safety surfacing, contained by concrete kerbs. There is 1 bench and 1 bin. The play equipment comprises: flat swings, basket swing, roundabout, bouncer and a climbing structure with a slide. Its secluded location tucked away at the corner of Freeland Place, between 2 residential blocks will limit natural surveillance of the site. The site configuration and adjacent busy road allows only one entrance to the space.

No action necessary. Monitor condition of the play facility and appropriate use of the facility. Cut back vegetation to reduce anti-social behaviour.

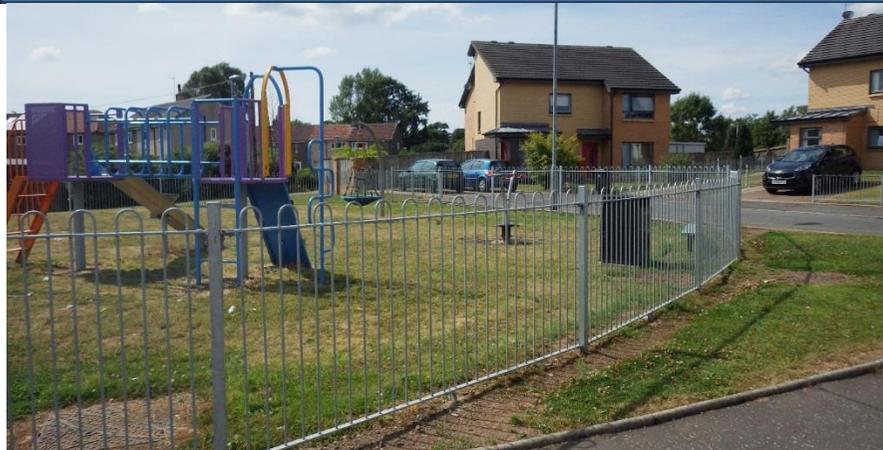
STR067

Small fenced play area set in an area of grassed open space, surrounded on all sides by houses and a residential road. There are 2 picnic benches outside play area. There are 2 gates, 2 bins and 1 bench. The play area comprises equipment for toddlers and young children, including: a climbing frame, 1 basket swing, rocker, dish roundabout and a wooden balance bar. The safety surfacing is grass matting and mown grass, set within fenced area. The play area lacks interest and has limited play value, catering mainly for younger children. There is no natural landscaping in the open space, which might encourage more informal play and recreation.

On the whole the play equipment is fit for purpose. However, balance bar is damaged. There is a bit of litter throughout the site.

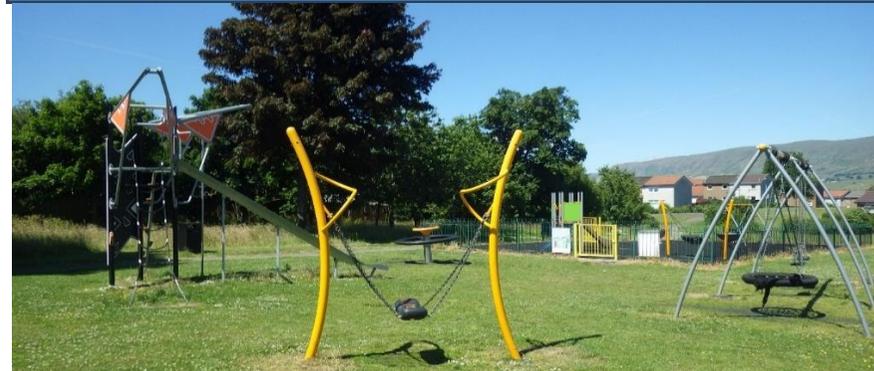
STR068

The play area is located to the north west of a large open space in the heart of a residential area. There are two parts to the play area, including: a fenced play area for younger children and recently installed equipment outside the play area, for older children. Equipment includes: 4 Seat Rocker, Cradle Swings, Dish Roundabout, Rocker, Toddler Unit, Basket Swing, Swings x 3, Nexus Surfer, Slide Unit and Orbit. There are 2 gates to the play area and a bin and bench (outside play area). There has been some damage to the cradle swing netting. The safety surfacing is recently laid wet poured surfacing. There is plenty of grassed open space in the rest of the park, which can be used for informal play and recreation. Adjacent to a partly fenced football pitch (rusty fencing). Access to the park is not good from the west, due to the lack of entrances to the neighbouring residential streets and the secluded location of the entrance at the south western corner.

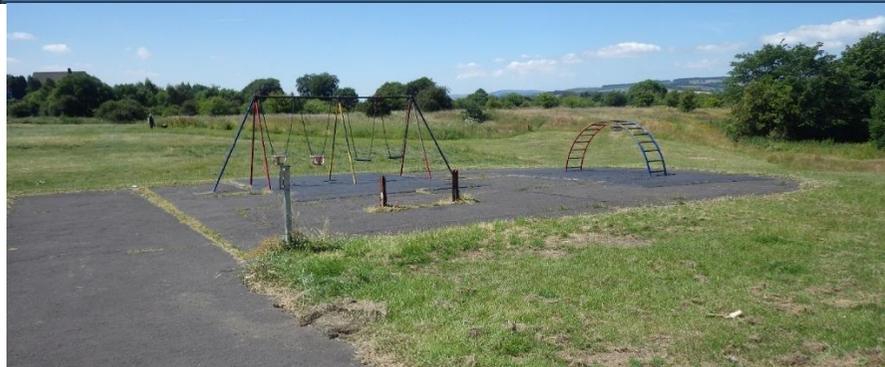
STR070

Small area of play space located to the east of Tintock Park / Alloway Grove Park. The site can be accessed along a path leading from Alloway Grove. There is an area of bitmac surfacing, with grass matting fixed on top. The play area appears to have contained more pieces of equipment, which have been removed. There are a set of swings and a climbing frame remaining.

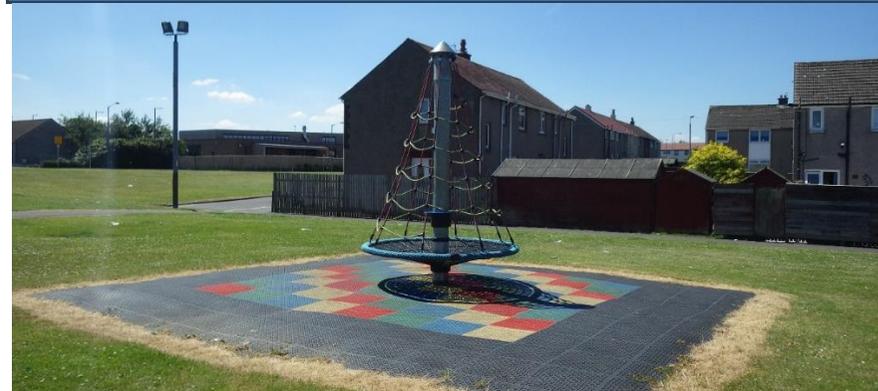
STR071

Small play area set within an open space, located on a busy main road and surrounded on 3 sides by houses. The play area is located beside the main access path, which crosses the park. The play area is unfenced. The pieces of play equipment are set in grassed area, with grass safety matting. There are swings, slide, roundabout, 2 benches, a bin, a climbing spring frame and a skateboard balance. There is an open grassed area for informal football kick about. There is no landscaping in the open space and no other features that might offer opportunity for natural play. There is a school on the other side of the road, so the play area might be well used after school hours. The open space contains floodlighting and roadside lights. There are 2 rusty poles which once had signage. The play equipment is a mix of types, which does not cater for any age group in particular. There are pieces of equipment for toddlers and school aged children and for youths.

Upgrade the play area in the medium term, providing facilities for young children and school aged children. The facility should provide fencing along the busy Langmuir Road. The capital monies received from the Cleddans Field housing development have been allocated to the upgrading of the play area at Afton View. Plans should upgrade the play area to a NEAP.

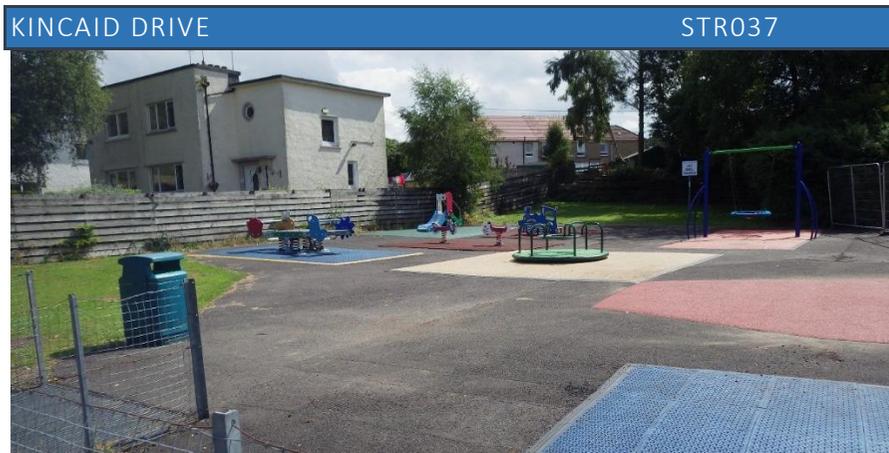
Small play area on the edge of the settlement, with attractive views across the adjacent fields. The facility is a fenced children's play area. There is a fenced grassed small football area on the opposite side of the road. There are works underway to install swings and a climbing frame, with wet poured safety surfacing. There is also a roundabout and basket swing, set on existing safety mats. The equipment for toddlers consists of a see saw, 2 bouncers, train with seats and a slide. The boundary fencing is a mesh fence, with a dog grill at the entrance. There is only 1 gate. There is 1 bin and 1 bench. The fencing is in reasonable condition but could be replaced.

The quality assessment reflects the location in a small site, surrounded by houses, without much landscaping. The overall landscape quality of the site should be improved with amenity tree and shrub planting. Replace the fencing in the longer term. The quality of the site should be improved with amenity tree and shrub planting and boundary improvements.

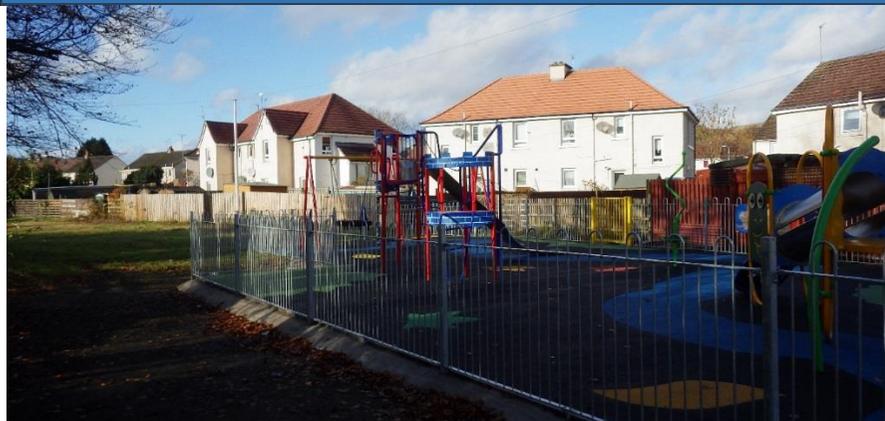
STR039

Bencloich Road play area is a recently developed facility, located in the heart of a residential area to the east of the town centre. The site is set within a pocket of grassed open space, surrounded on all sides by the rear gardens of the adjacent houses. The site entrance is from Bencloich Road, to the east, where there is a derelict former shop. The play area is not visible from the road and there is no natural surveillance, apart from the overlooking houses. There is no indication of the presence of the play area from the adjacent roads. There is a wide tarmac access road besides the shop and leading to the play area. The play area is fenced, with 2 gates. There is a good range of play equipment including: Vertical Rotator, Multi Climbing Unit x2, Roundabout, Swings x 2, Basket Swing, Toddler Swings and a See Saw. There are 2 benches and a bin. The play area provides a range of equipment for primary school aged children.

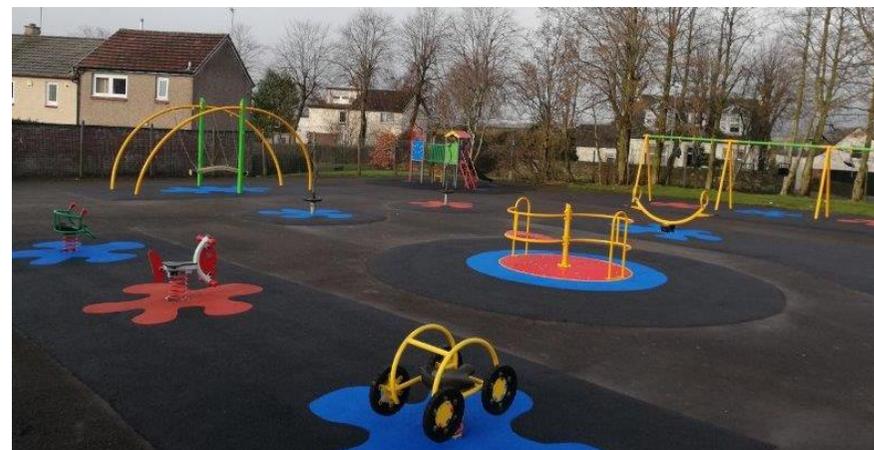
STR057

The play area has been partially upgraded recently and is fit for purpose. However, one of the bins is damaged.

Some minor works to improve setting of the play area and the boundary fencing, making the play facility more attractive and welcoming.

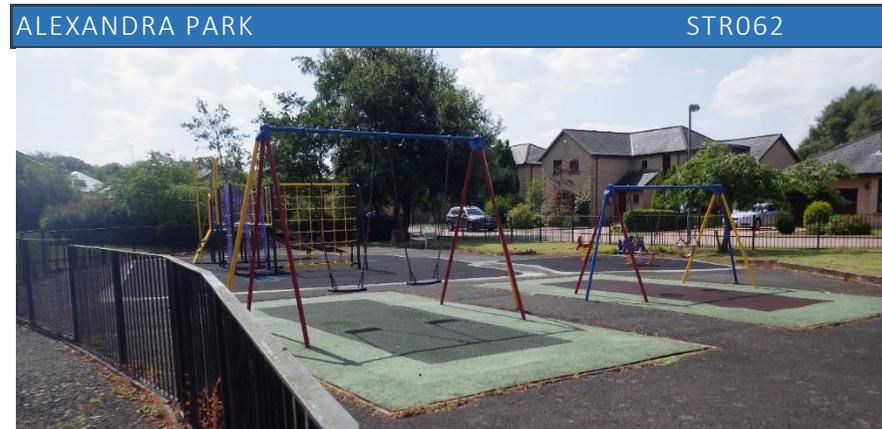
The play equipment is currently fit for purpose. However, the springs on gates are not working and need oiling / repair. The boundary fencing requires repainting and repair. The raised woodland edging around the bitmac area is rotting and presents a trip hazard and is weedy at the edges.

Some minor works are required to repair / repaint the fencing and the gated access points. Replace the wooden edging around the bitmac surfacing. Replace the safety surfacing and edging. Fix the self-closing gates. Replace the seating. (Note: the play area is on private land).

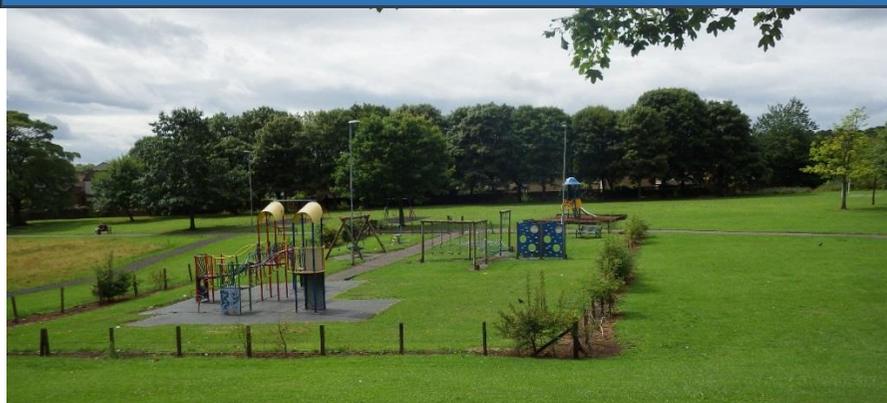
B/M001

The fence around the play area is broken in places and no longer functional and only parts of the hedgerow have established. The wooden play frames require treatment. The gate is broken and is tied open, through the use of cable ties and a post. The paint on the climbing unit is peeling and requires repainting. The grass matting is lifting in places. The wooden edging around the play equipment is rotting and is broken.

Undertake some minor works to ensure the play area remains fit for purpose. Replace the wooden edging and treat the wooden posts that form part of the play equipment. New fencing is scheduled to be installed. Replace multi-play unit and consider wet pour safety surfacing.

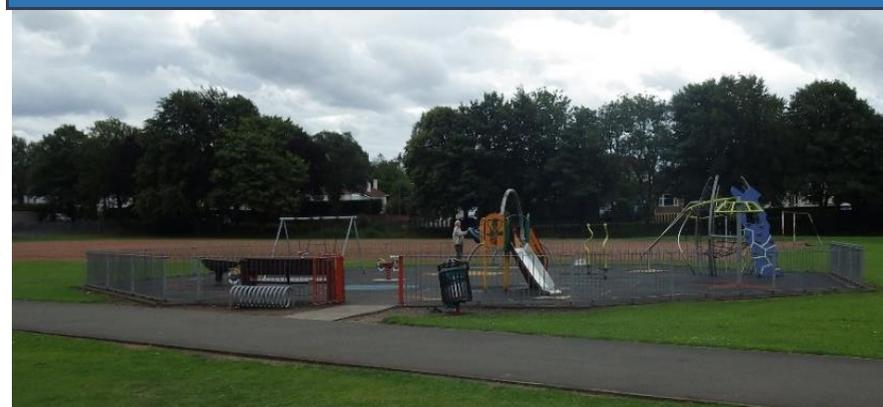
B/M002

The play area has been recently installed and is fit for purpose. However, the spring on the gate is broken, there is litter and the bin is damaged.

The play area is showing signs of wear and tear and would benefit from some minor works to ensure the play area remains fit for purpose. Addition of play facilities for older children / young adults to upgrade the facility to a NEAP. Adult fitness could be a consideration at this location.

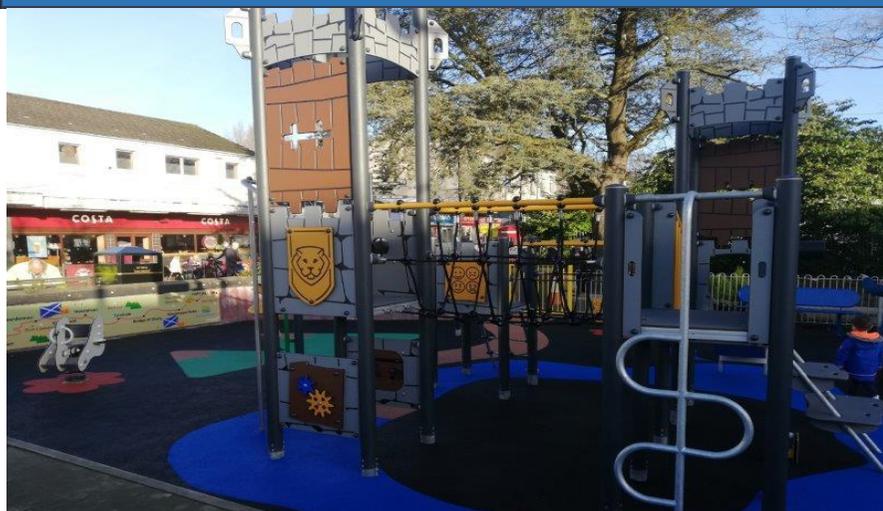
B/M006

The play area has recently been replaced. The walls within the play area are painted and require repainting.

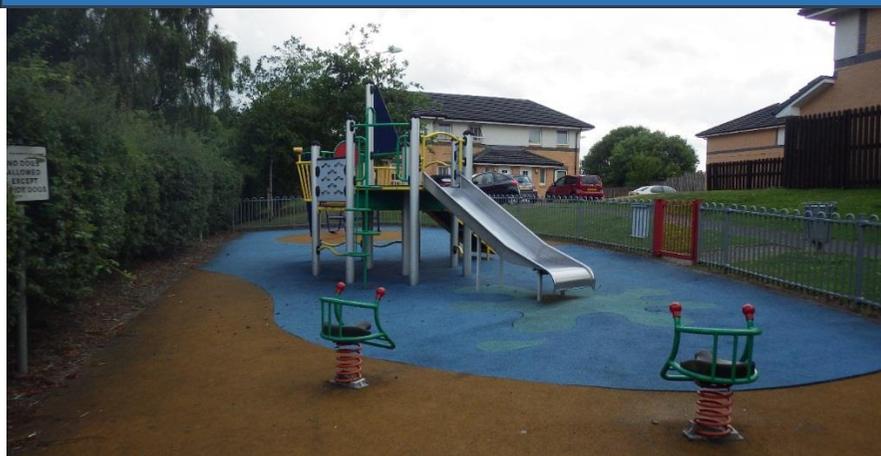
STR041

The play facility is currently fit for purpose. However, there is some litter. The wheel dust path needs topping up as there is water damage caused by run-off. The safety surfacing is beginning to lift along the joints, in places.

Undertake minor repairs to ensure that the play area remains fit for purpose.

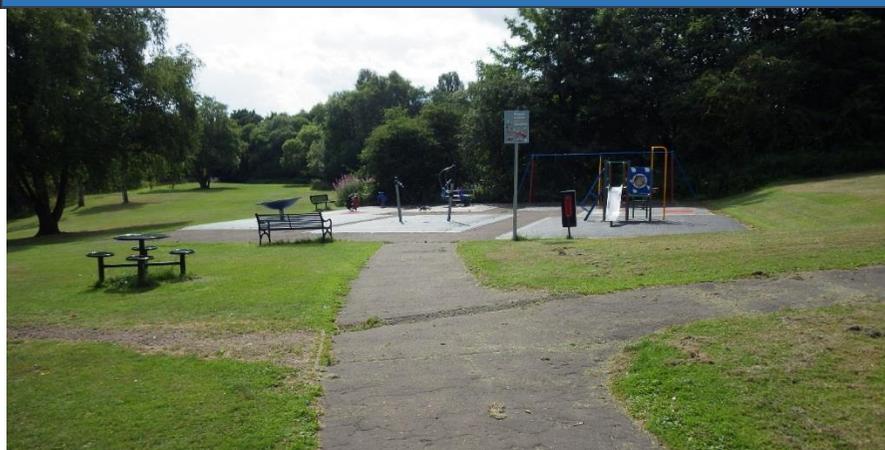
STR045

The play facility is currently fit for purpose. However, the bitmac surface is cracked and weedy in places.

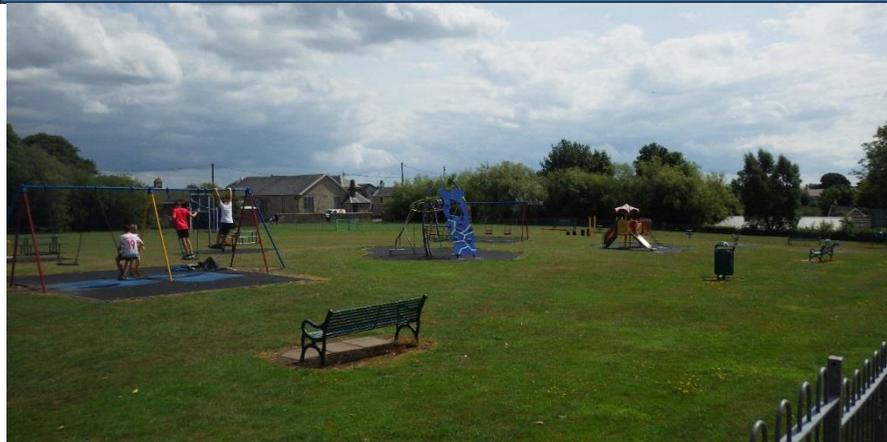
STR035

The play facility is currently fit for purpose. However, there is some litter in the play area. The old piece of climbing frame is in reasonable condition but in need of repainting and some repair.

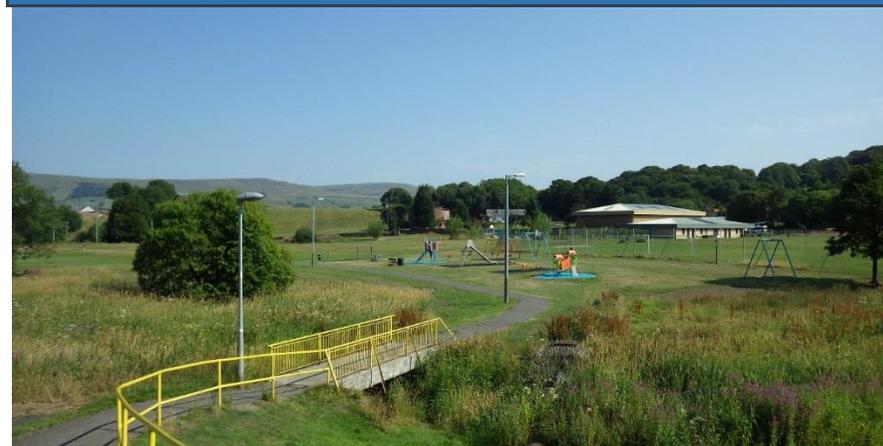
STR048

The play and fitness trail are in overall good condition. However, the fitness trail is beginning to look a bit dated, with some pieces of equipment needing mould removal and to be repainted. There is some litter around the fitness trail and the long grass under the equipment needs strimming. Improvements to the play area are ongoing, with new pieces of equipment recently installed. The swinging bars need repainting as they are quite old, but in reasonable condition.
